DESICCATION OF A COMPACTED CLAY LINER IN A COMPOSITE LANDFILL LINING SYSTEM

BY CURT BASNETT and MARTIN BRUNGARD

The clay desiccation of a landfill composite lining system

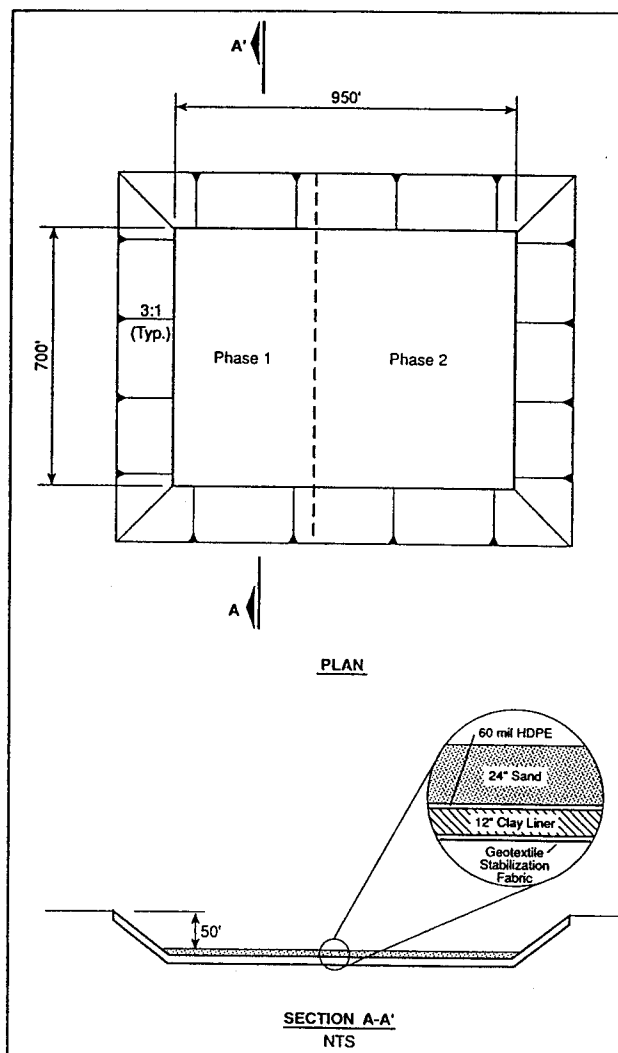
Figure 1 A plan view of the landfill.

We have observed what may be a unique phenomenon during the expansion of a landfill. The existing bottom liner consists of a 60-mil HDPE geomembrane overlying a 12-inch compacted clay liner. The clay liner was constructed with rigid QA/QC procedures and was observed to have permeabilities ranging from 10⁻⁷ to 10⁻⁸ cm/sec. The cell cross-section is shown in Figure 1. The bottom of the cell was covered with at least 2 feet of

The existing landfill was designed to be constructed in two phases. Figure 1 shows a plan view of the landfill. The new clay liner for the cell expansion is to be feathered into the existing clay liner. When the liner was removed to expose the clay on the slopes, the existing clay was found to be highly desiccated.

This desiccation was quite severe, with cracks averaging 1/2 inch to 1 inch

wide, extending the full depth of 12 inches.

Further investigation revealed that desiccation extended at least 100 feet to 150 feet back from the temporary end beneath the HDPE liner.

The clay located farther away from the temporary end of the liner appeared to be in worse condition than clay near the temporary end of the lining.

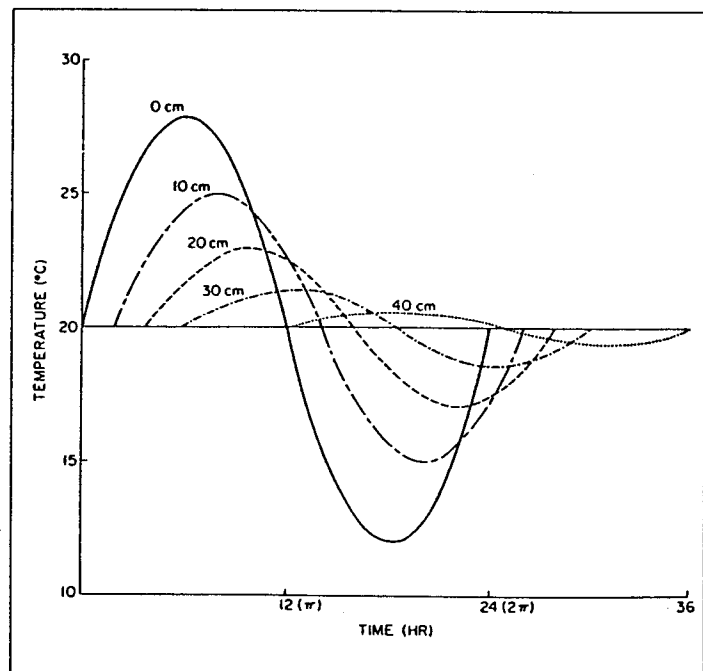
Figure 2 Idealized variation of soil temperature with time for various depths

Note that at each succeeding depth the peak temperature is damped and shifted progressively in time. Thus, the peak at a depth of 40 cm lags about 12 hours behind the temperature peak at the surface and is only about 1/16 of the latter. In this hypothetical case, a uniform soil was assumed, with a thermal conductivity of 4×10^{-3} cal/cm sec deg and a volumetric heat capacity of 0.5 cal/cm³ deg. From: *Fundamentals of Soil Physics*, Hillel

Figure 2 shows the effect of soil thickness on temperature damping. The soil parameters modeled in the figure are roughly analogous to the characteristics of a drainage sand.

It appears that a soil cover over the liner is one solution to this problem. The soil surcharge will press the liner into intimate contact with the clay. This may prevent free liquid from migrating down the slope. The soil also serves as an insulating media to dampen the temperature variation.
