DAM REHABILITATION USING GEOSYNTHETIC CLAY LINERS

This paper was presented at the American Society of State Dam Safety Officials '05 Conference.

Jim Olsta, P.E. and Don Carine, CETCO

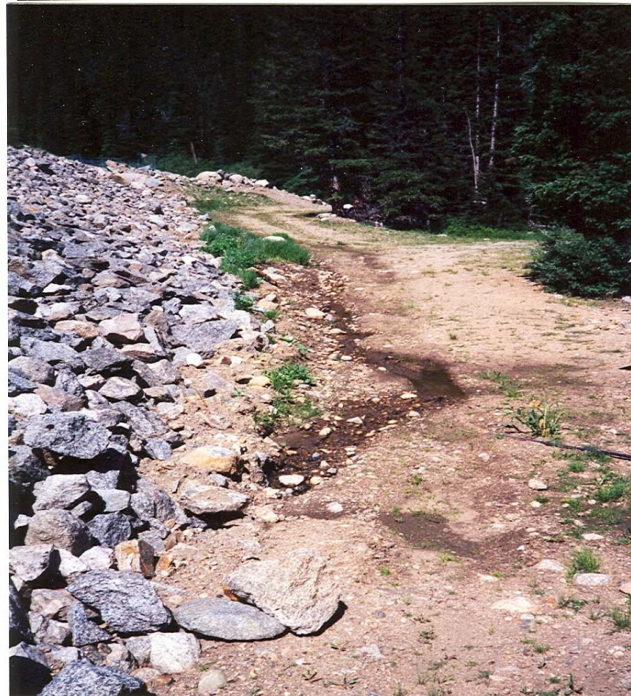
The Idaho Springs Reservoir (Figure 1) is located on the eastern front of the Rocky Mountains, 40 miles west of Denver, Colorado. Its primary function is to provide water supply storage for the City of Idaho Springs, Colorado and the surrounding service areas. Built in the early 1900s, an earthen dam controls flooding and protects camp sites and recreation areas in the valley below. By 2000, the Office of the State Engineer, Dam Safety Branch, had placed restrictions on the reservoir's capacity due to the deteriorated condition of the dam and evidence of significant seepage. Prior to the lining project, five significant seepage locations were observed on the downstream side of the dam. One seep exited onto the berm road at the downstream toe (Figure 2) and there was standing water

around an observation well located just downstream of the dam. The reservoir capacity is 270 acre-feet at the crest of the spillway, however, water storage was limited to just 120 acre-feet because of the excessive dam embankment seepage.

Figure 2. Seep at downstream toe of dam prior to rehabilitation

The final approved design called for the placement of a Bentomat® CLT geosynthetic clay liner (GCL) along the dam face to the spillway abutment and past the outlet structure. In addition to bentonite clay sandwiched between two geotextiles, Bentomat® CLT has a 20 mil HDPE membrane laminated to the outer surface. This provides a composite hydraulic barrier with a maximum hydraulic conductivity of 5×10^{-10} cm/s per ASTM D5887. Direct shear testing was performed between the GCL and the adjacent soils under hydrated conditions per ASTM D5321. The test data indicated a peak friction angle of 45 degrees.

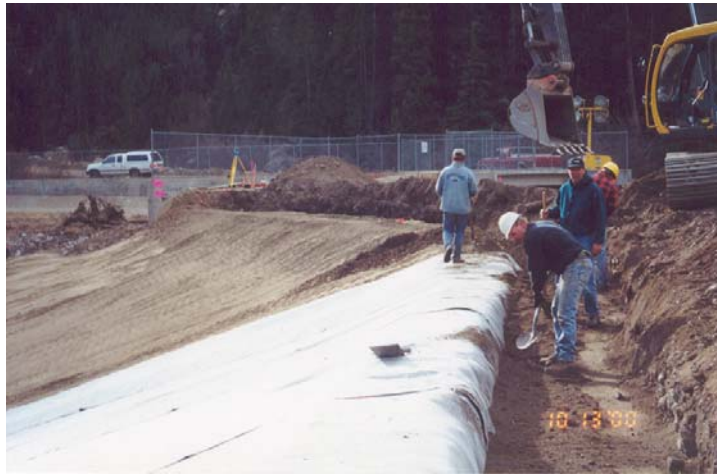
Figure 3. GCL Installation

Repairs to the dam's upstream face began in the fall of 2000 and were completed in the summer of 2001. The GCL was delivered by flatbed truck. Rolls were 15-feet wide with a panel length of 150 feet. The self-sealing ability of the bentonite allowed for a 12-inch panel overlap without the need to

weld the geomembrane panels. The GCL panels were anchored into a trench at the crest of the dam and unrolled down the dam face with a backhoe and spreader bar assembly (Figure 3).

Originally, the GCL was planned to be keyed into the clay aquitard below the reservoir. However, large boulders were encountered in the subsoil at toe face. Alternatively, the contractor rebuilt the subgrade and the GCL was run out 20-25 ft past the toe along the base of the reservoir. Approximately 100,000 square feet of GCL was used in total. Cover soil was placed over the GCL and the existing rip-rap cover layer which had been removed, was screened and reset at a uniform 3-foot thickness across the dam face.

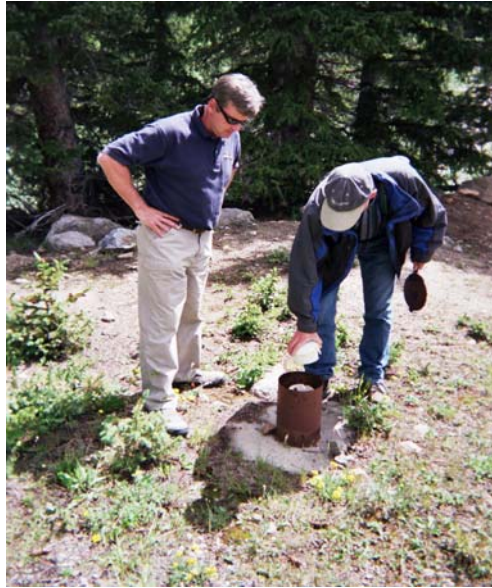
Since the lining project, the downstream toe of the dam has remained dry and water in the observation well just downstream of the dam is 6' below the ground (see Figure 4). Seepage has been greatly reduced to acceptable levels.

Figure 4. Observation well downstream of dam.
