GCL AND INCOMPATIBLE SOIL CASE HISTORY

A GCL AND INCOMPATIBLE SOIL CASE HISTORY: A DESIGN PROBLEM

Ian D. Peggs

Proceedings of the GRI-12 conference on
"Lessons Learned from Geosynthetic Case Histories"
R. M. Koerner, G. R. Koerner, Y. G. Hsuan
and T.-Y. Soong, Eds., GII Publications
Philadelphia, PA USA 1998

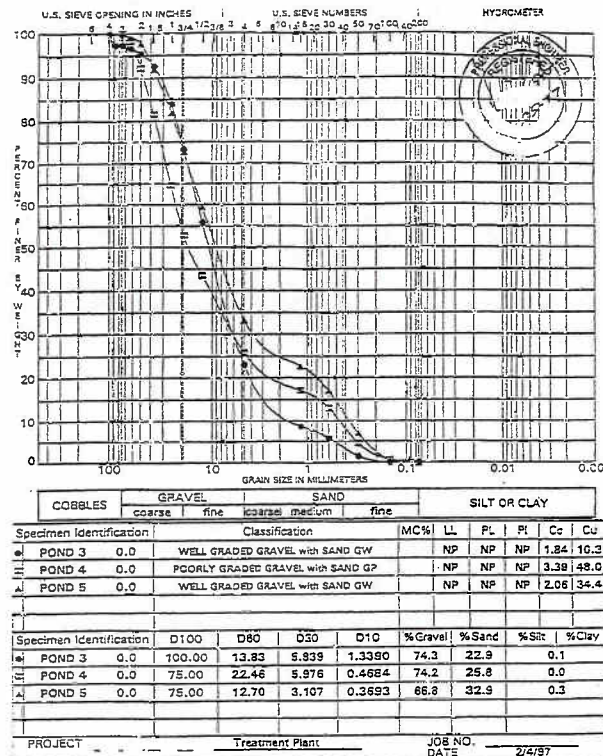
Figure 1. Gradation Curve

Gradation curves (Figure 1) for the soil from each of the three ponds show that the subgrade soils did not meet this requirement. Only about 10%, rather than 80%, of the soil would pass a US #60 sieve. Hence the subsequent loss of this small amount of fine material in the subgrade which, at the time of preparation would just be forming a bridging surface layer above the stones. Subsequent settlement and relative movement of the subgrade stones during continuing construction and filling of the pond would cause erosion and loss of the fines with consequent lack of support for the GCL. In addition to the consequent lack of confining pressure on the GCL are areas where coincident stone impingement below and above the GCL causes sideways dispersion of the bentonite, contact of the two geotextiles, and even puncturing of the geotextiles. At such locations, once water flow through the GCL commenced, bentonite would have been washed out of the GCL, fines in the subgrade would have been eroded, and the leakage rate would accelerate.

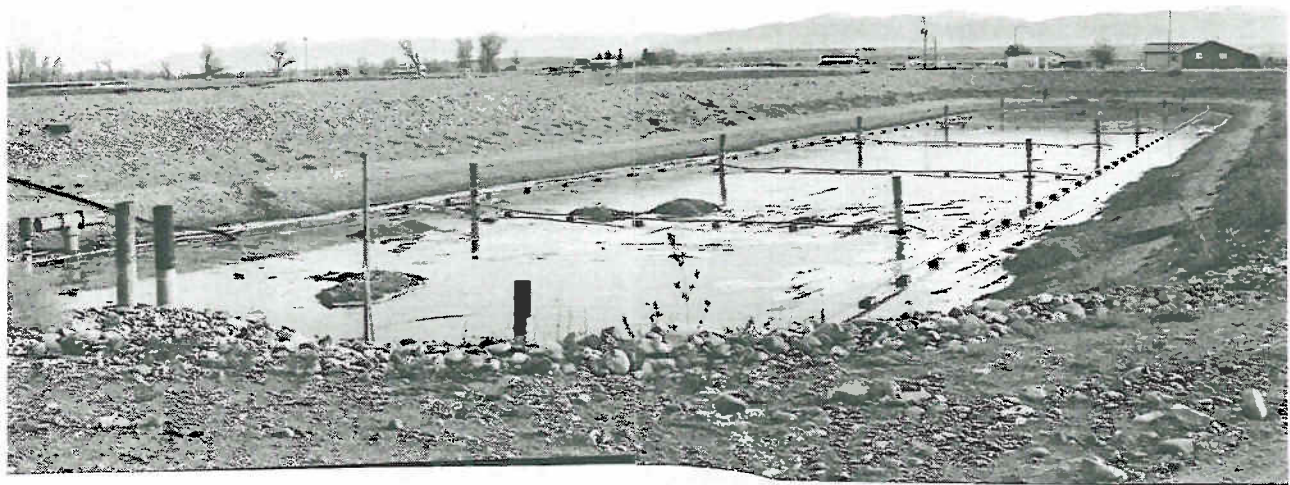
Figure 2. Overview of Pond

On arrival at the site one of the large ponds was as shown in Figure 2. The pipe systems were removed and the remaining water drained from the pond.

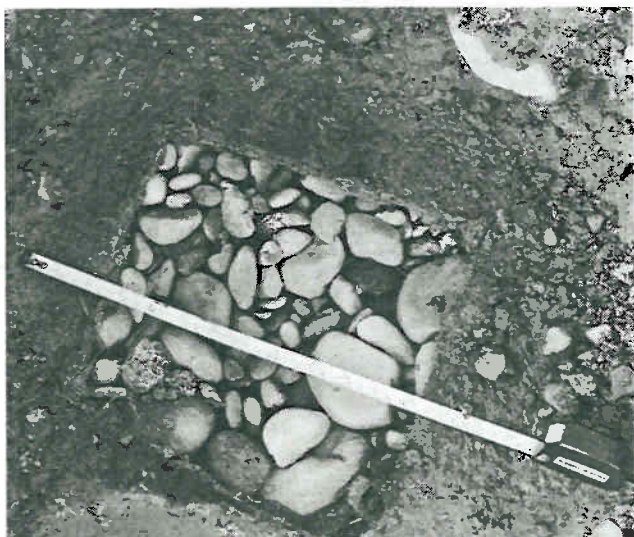
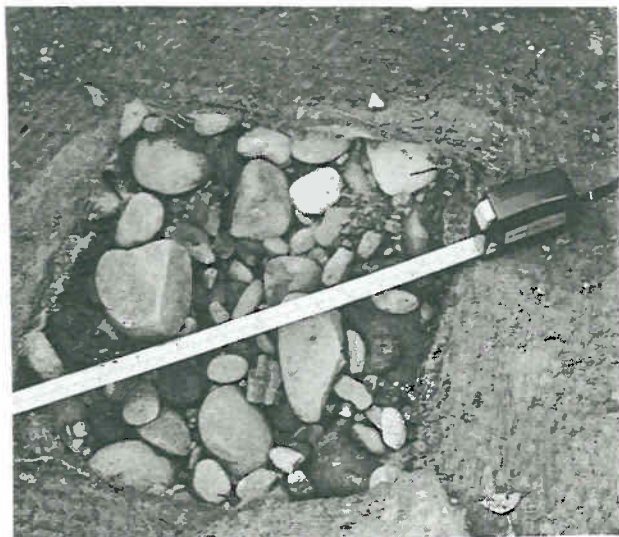
Figure 3. Soil surface under GCL

Four pits were noted in the corner of one pond from where the engineer had previously removed GCL samples. Figure 3 shows the subgrade exposed at two of these samples. It is not "smooth and free of all rocks, sharp stones,with no sudden, sharp, abrupt changes or breaks in grade" as required by the project specifications. Many of the larger stones are sharp and angular. Clearly, the GCL had been lying on the tops of the stones and bridging the gaps between stones. Therefore it had not been uniformly supported by the subgrade as required for the generation of a uniform confining pressure and maximum impermeability.

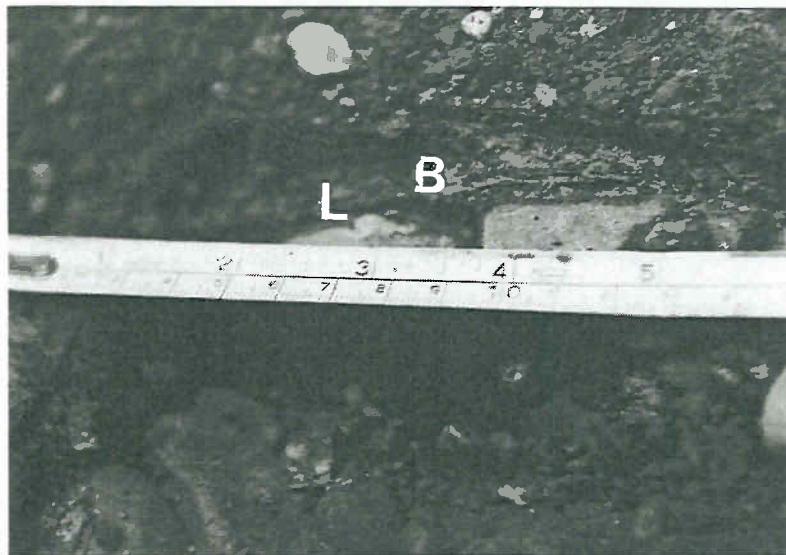
Figure 4 shows the bridging effect and thinning of the GCL over a rounded stone. In extreme cases the bentonite will all be squeezed sideways, or outwards, the geotextiles on each side of the GCL will make contact, and the liner will start leaking.

Figure 4. Thinning of GCL over stone on left, and bridging between stones.

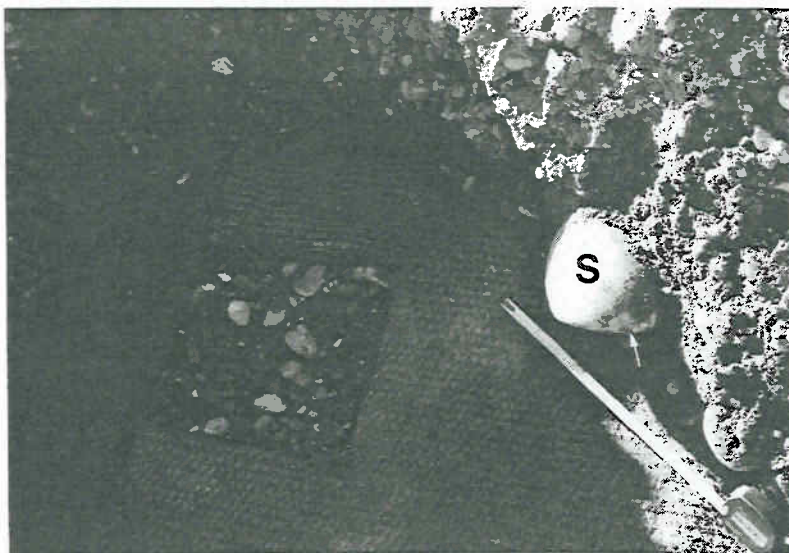
Figure 5 shows the location of one of the engineer's samples removed at a seam, with a large adjacent stone resting on the GCL and with a smaller stone underneath it. There were many stones contacting the GCL that were larger than the maximum size of 25 mm recommended by CETCO, and other GCL manufacturers. The GCL was cut further away from the seam to reveal the powdered bentonite correctly placed in the seam overlap (Figure 6). The overlap was further exposed and a 600 mm length of bentonite powder scraped off the bottom GCL. This material was subsequently dried in an oven and found to weigh 200 g. With the material left on the GCL this would effectively meet the manufacturers requirements of 114 g of bentonite per 300 mm of seam. Thus, it could be assumed that the seams had been correctly made, so would not be responsible for the leakage.

Figure 5. GCL seam. Note larger stone to right with smaller stone underneath it.

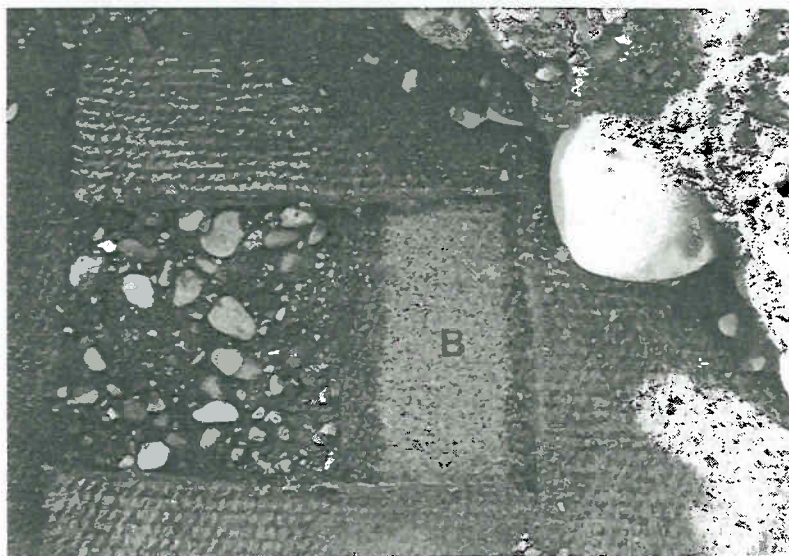
Figure 6. Powdered bentonite in seam overlap

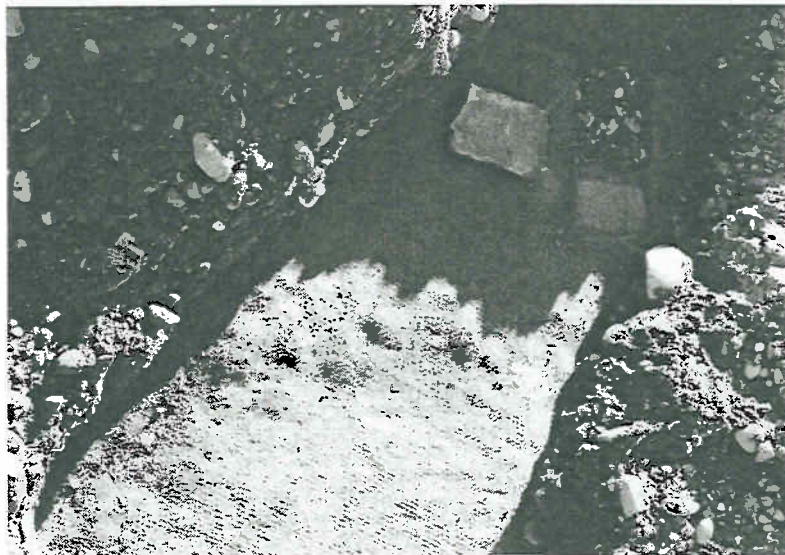
Figure 7 shows several stones pushing upwards into the GCL. A large stone nearby, above the GCL was measured at about 200 mm long by 100 mm diameter. There were many areas where the GCL was deformed from stones both above and below the GCL. Strains in the region of 7 % were determined for some of the larger deformations. Such strain is not sufficient to cause failure of the GCL, but indicates that there might be sites where strains exceeding 15%, sufficient to cause failure, have occurred.

Figure 7. Profiles of stones under GCL

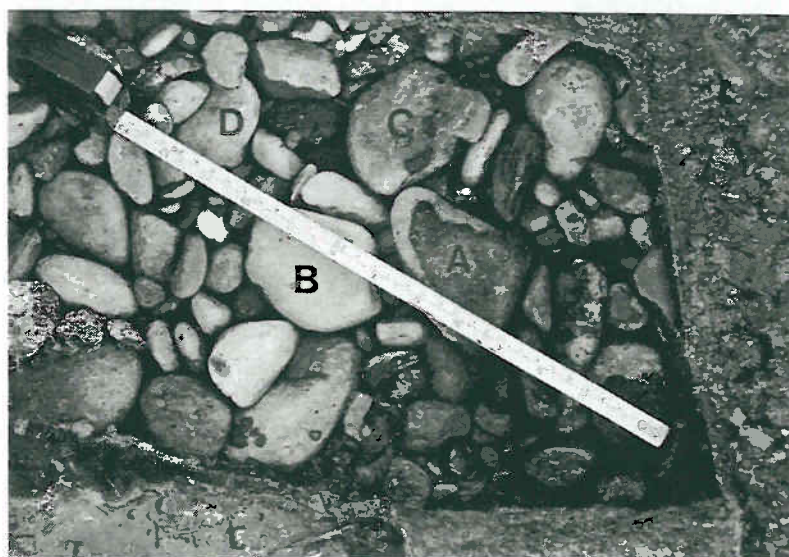
Figure 9. Stones in subgrade

When a further sample of GCL was removed adjacent to one of the engineer's samples, there were again no fines between the stones (Figure 8) – the water had washed them all away. This was the condition almost everywhere that the subgrade was exposed. At one location (Figure 9) the dimensions of the stones and the gaps between them were measured, and were found to be:

- Triangular stone (a); 100 mm
- Gap between triangular stone (a) and stone to left (b); 25 mm
- Gap between stones (c) and (d); 50 mm

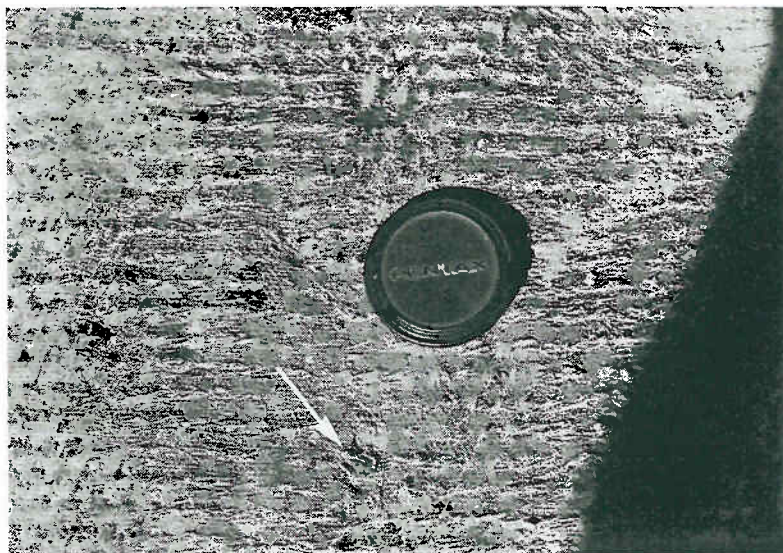
A section of the GCL in one of the large ponds was exposed (Figure 10), to reveal several small holes in the upper geotextile. The GCL was removed, and exposed one large stone almost 100 mm long (Figure 11). Two of the holes were at the ends of one long edge of the stone. The largest hole was at the location of a 25 mm diameter rounded stone.

Figure 10. Small holes in GCL

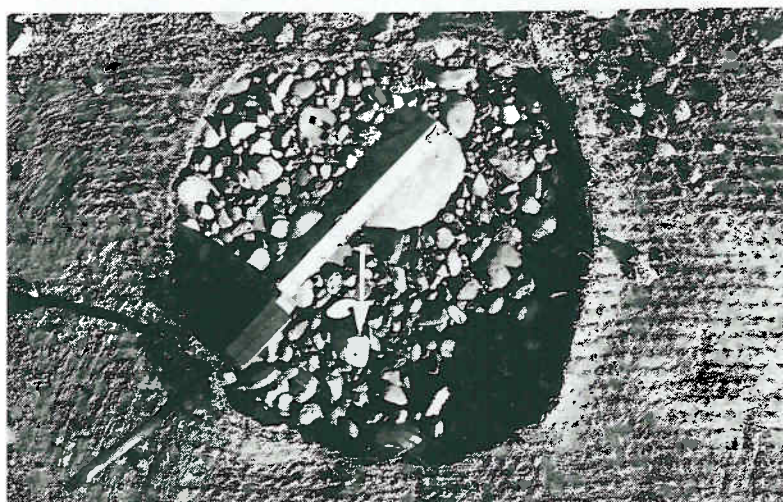
Figure 11. Round (arrowed) stone caused hole in Figure 10.

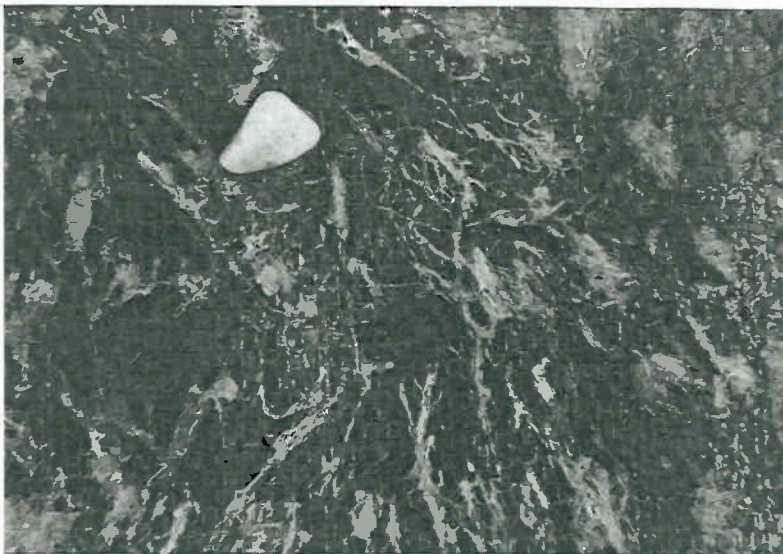
In another randomly exposed section of GCL two small holes were found, one being caused by a very small stone, about 10 mm long (Figure 12) that had been pressed into the geotextile by a much larger stone above it. When the GCL was pressed, bentonite was extruded through these holes. When the GCL was cut out, the subgrade appeared to be of reasonable quality (Figure 13), but there were still several stones with dimension of about 40 mm.

Figure 12. Small stone that was pushed through the geotextile by a large stone

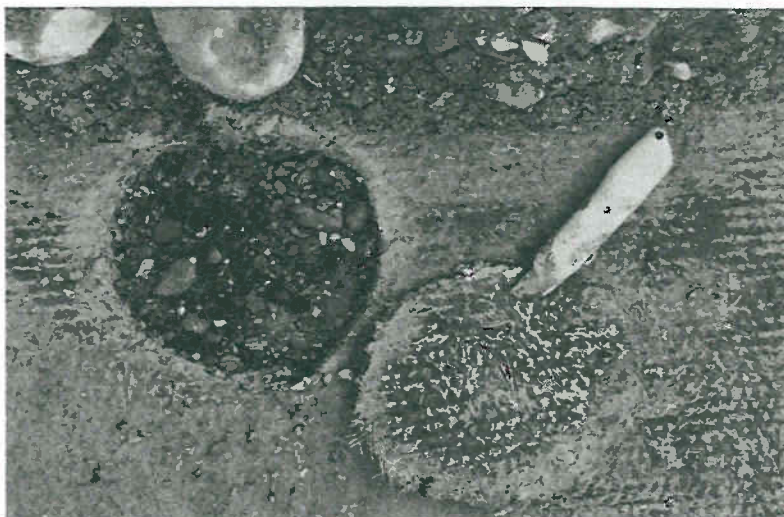
Figure 13. Subgrade at hole caused by small stones in Figure 12

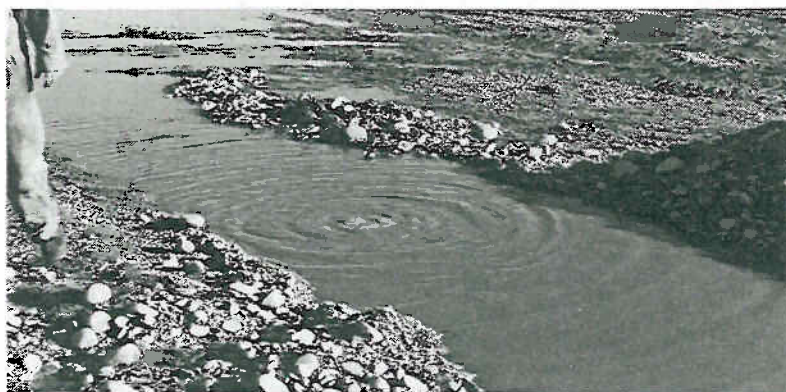
At one stage in the investigation, water in a pit on the floor of the pond was seen to be welling upwards (Figure 14) through a GCL sample hole that had not been repaired. This suggested a method for performing a general leak survey.

Figure 14. Water rising through sample hole in GCL

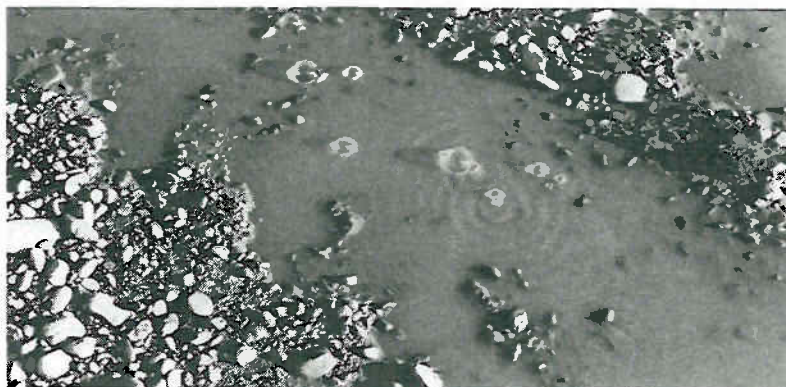
The underdrain system of the pond was pumped almost dry and then allowed to refill. As filling proceeded, air under the liner was pressurized by the rising water and forced through the holes in the GCL. It then bubbled up through the cover soil (mud) and water as shown in Figure 15. These locations were flagged. In total 51 single and multiple leak indications were marked as shown schematically in Figure 16. Three of these locations appeared to be quite significant leaks, probably larger than the ones already uncovered. The same procedure was followed in the other large pond with very similar results.

Figure 15. Bubbles above holes in GCL

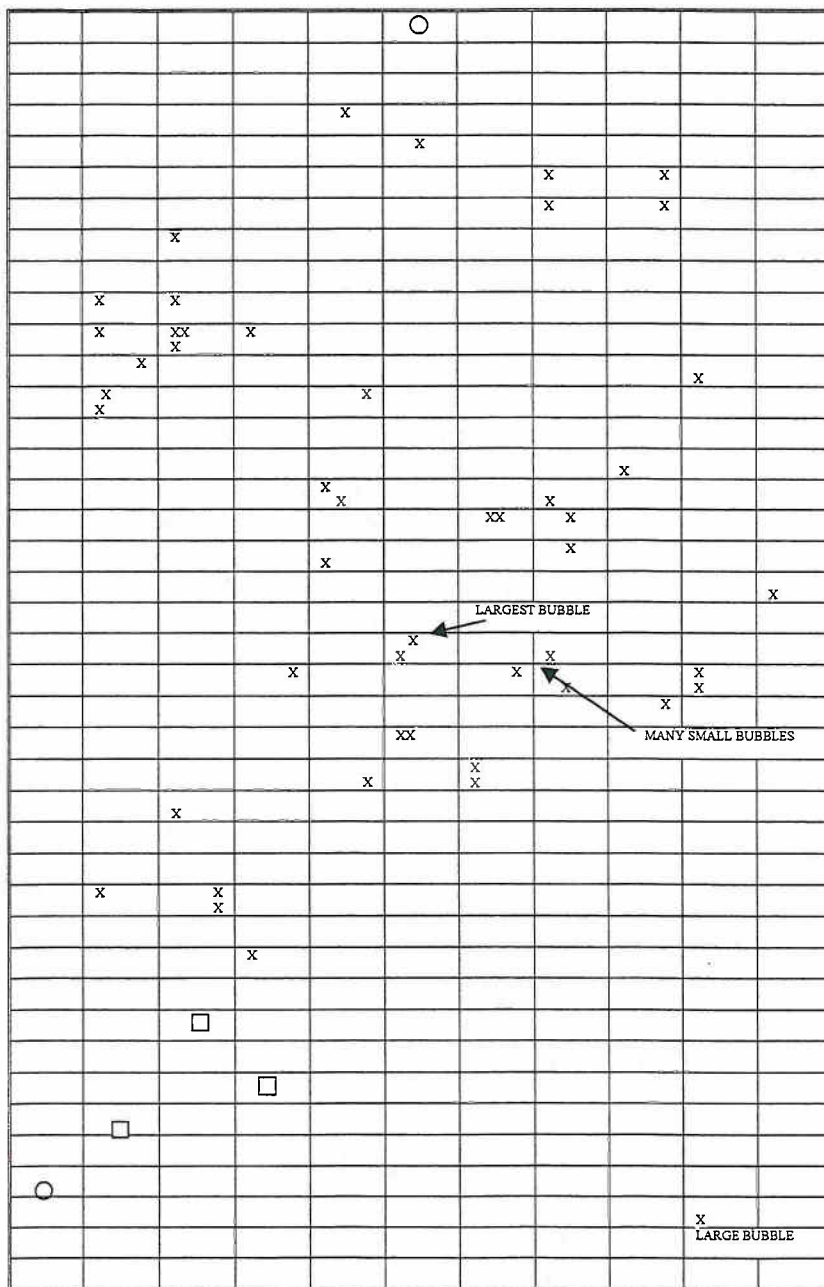
Figure 16. Schematic locations of leak indications.

X = bubble locations, O = inlet pipe, □ = sample holes not patched

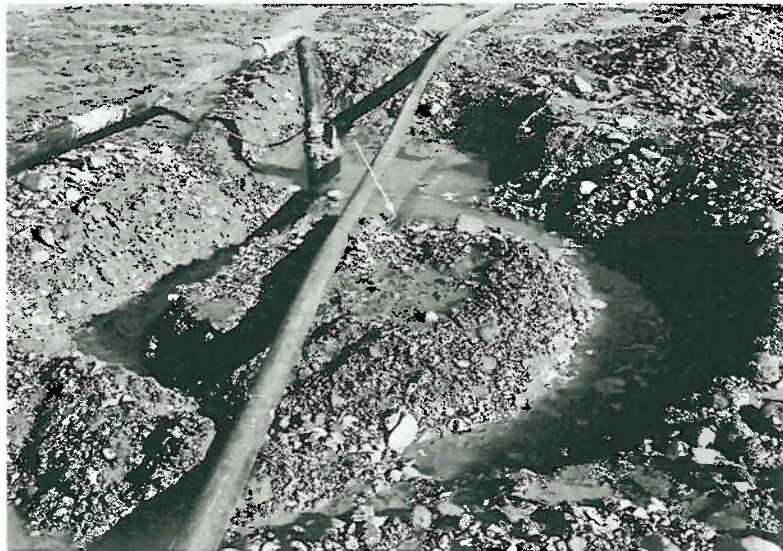
The indicated leak location in the bottom right corner was carefully uncovered. A channel down to the GCL was dug through the cover soil around the marked location (Figure 17), and a pump was used to remove water draining into the channel. The cover soil was carefully removed from the channel in towards the marker and the hole. Figure 18 shows several large stones undisturbed from their original locations directly above the marked location when the water over the GCL was about 25 mm deep. The stones and soil were carefully removed, without damaging the GCL to reveal a hole almost 13 mm in diameter completely through the GCL, as shown in Figure 19.

Figure 17. Channel around leak indication (flagged).

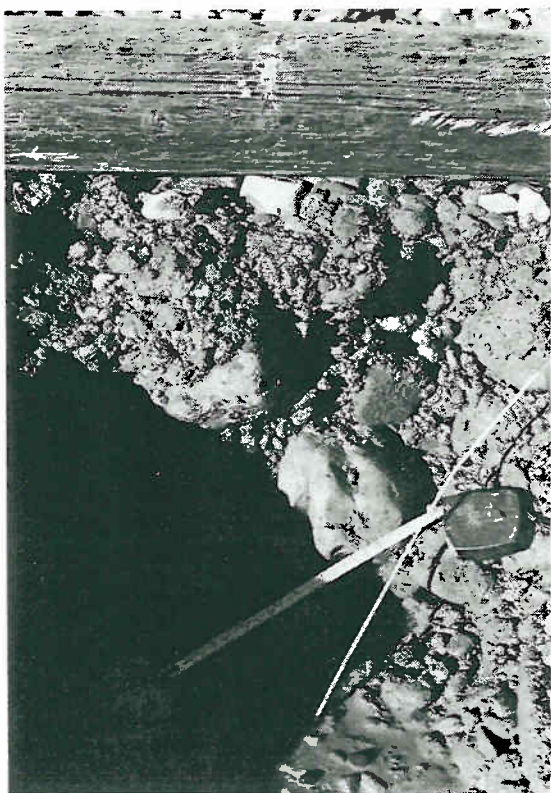
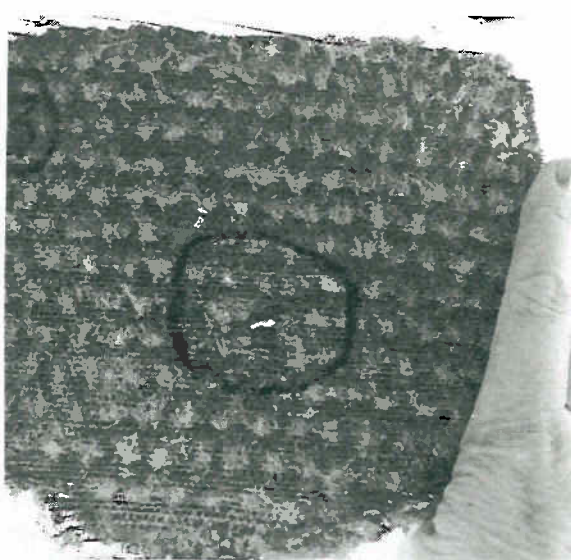
Figure 18. Large stones close to flagged leak.

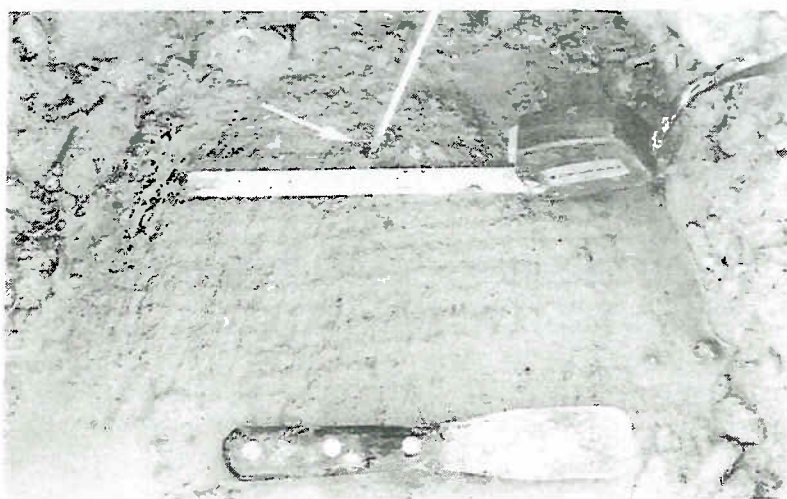
Figure 19. Hole (above tape) at location in Figures 17 and 18.

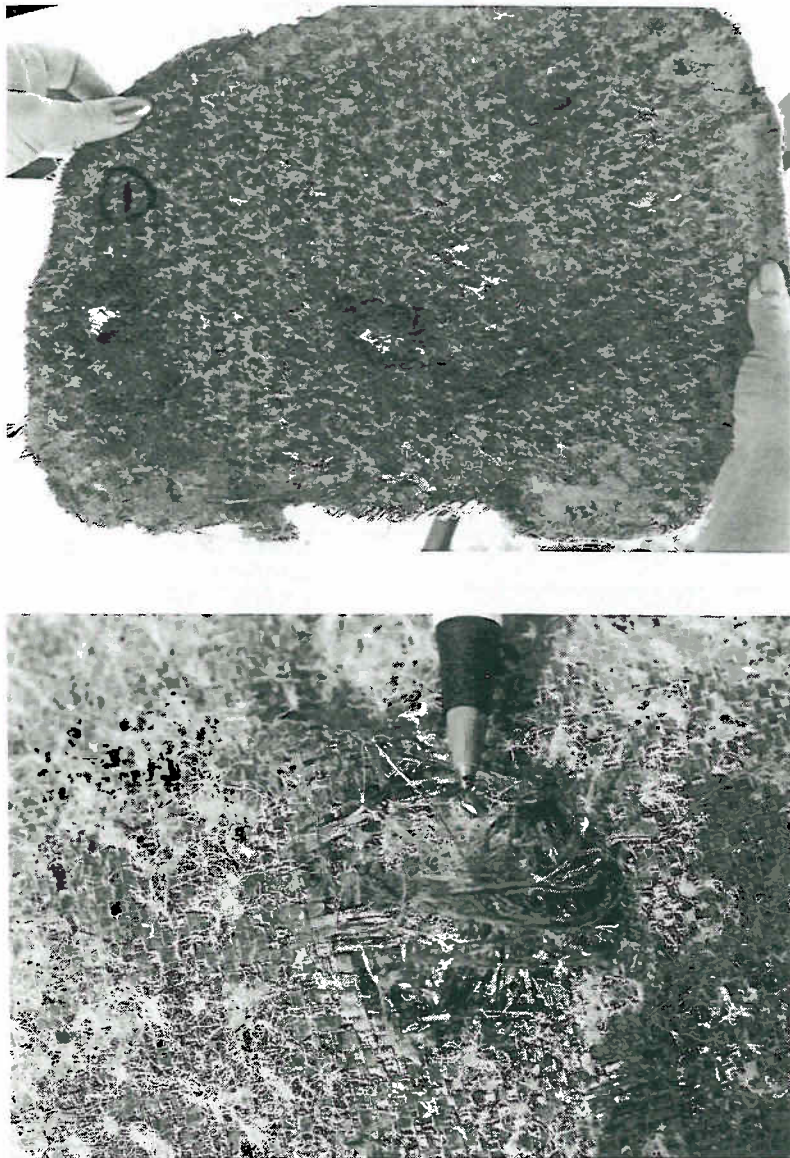
The most serious leak indication in the center of the pond was also uncovered. The sample removed from this location contained about 5 holes, the largest being about 40 mm in diameter. The stones above and below the GCL were about 50 to 75 mm in diameter. Figure 20 shows the holes in this sample after it had been dried and cleaned.

Figure 20. Holes in center pond sample.

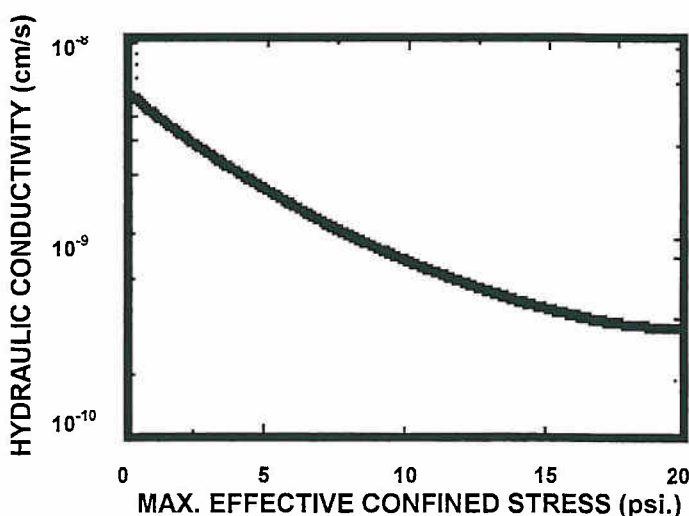
Figure 21. Hydraulic conductivity as a function of confining pressure

Figure 21 shows the hydraulic conductivity of a Bentomat GCL as a function of confining pressure. Assuming that the 450 mm thick cover soil has a density of 1.9 Mg/m^3 , thereby generating a confining pressure of 5.8 kPa (0.83 psi), Figure 20 shows the hydraulic conductivity of the GCL to be approximately $4.0 \times 10^{-9} \text{ cm/s}$. The leakage rate through such a GCL (thickness 6 mm) with 3.4 m of hydrostatic head will be 193 lphd. This is far higher than the typical 2 lphd usually specified for primary lining systems that incorporate geomembranes, and far higher than the allowable leakage rate.

In all their calculations the engineers simply used the hydraulic conductivity value of 5×10^{-9} cm/s or (1×10^{-9}) cm/s specified by CETCO, without any consideration of the actual on-site confining pressure. CETCO's specified value is based on a confining pressure of 35 kPa, much higher than generated by 450 mm of soil cover. Based on the aforementioned cover soil density assumptions, a 35 kPa confining pressure would require a minimum soil depth of about 2m, far in excess of the 450 mm used. Thus, the engineers should have used a more realistic hydraulic conductivity value in their calculations.
