## CASE STUDY: SURFACE IMPOUNDMENT FAILURE AND RECONSTRUCTION

## Surface impoundment design goals

## Surface impoundment rehabilitation

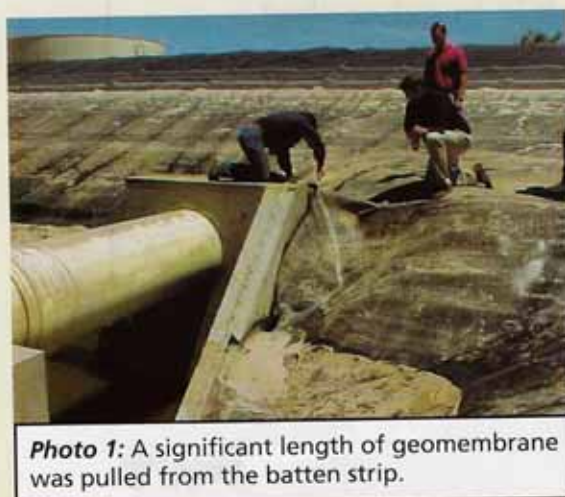
Photo 1 shows the extensive damage that was done to the HDPE liner during the final stage of hydrostatic testing immediately adjacent to a 30-in. (76.2-cm) water-inlet pipe. Extensive tearing of the geomembrane from the batten strips was observed and a significant volume of underlying soil had simply vanished. At this time, the designer suspected the quality of liner installation, the installer questioned the heritage of the designer, and the owner had lost confidence in all involved.

Photo 1: A significant length of geomembrane was pulled from the batten strip.

- The continued removal of the bedding material from beneath the liner removed support from beneath the geomembrane. Near the 30-in. (76.2-cm) pipe penetration, nearly 4 ft. (1.2 m) of fine-grained bedding layer was placed. As this thick

layer was removed, support of the geomembrane was lost and the geomembrane was forced to carry the weight of the water. **Photo 1** shows the significant length of geomembrane that was pulled from the batten strip as the underlying bedding layer eroded away. Once this degree of separation occurred, the water could easily move beneath the geomembrane since HDPE geomembrane actually floats in water (specific gravity at 0.95) and would not impede the water's flow. This resulted in scour of the smaller particle-size fraction adjacent to the concrete base wall. The geotextile cushion immediately beneath the geomembrane was wet and had been exposed to water.

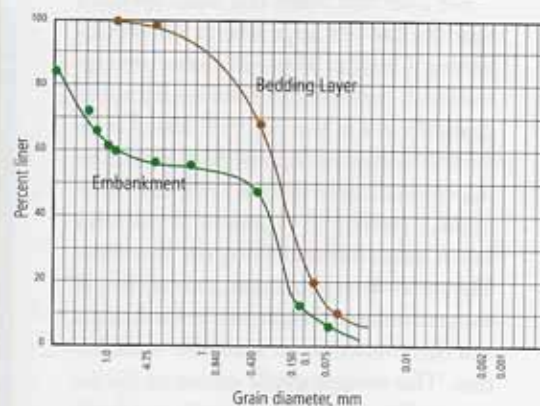
**Figure 1: Grain-size curves of bedding soil and embankment material around the pipe liner penetration.**

Figure 1 presents grain-size curves of the bedding soil and embankment material obtained in the immediate vicinity of the 30-in. (76.2-cm) pipe liner penetration. The embankment material is clearly gap graded (lacking coarse sand) but has approximately 50% of the smaller particle-size fraction. Since the material is non-plastic, the smaller particles consist of fine sand and silt.

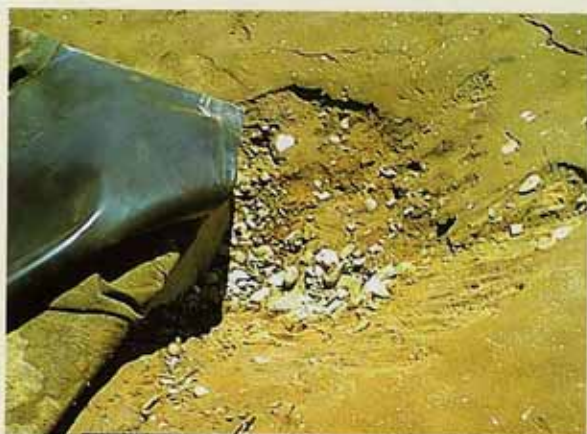
- As the head of water acting on the defect increased, so did the rate of leakage through the liner. Water flowing beneath the liner mobilized the fine sand and silt particles of the bedding layer. This slurry was able to pass through those areas of the embankment that did not have a high percentage of the smaller particle size fraction. **Photo 2** shows the southwest corner of the facility immediately after removal of the geomembrane. The bedding layer's scouring through the coarse subgrade is evident.

**Photo 2: Scour of bedding layer is evident after geomembrane removal.**

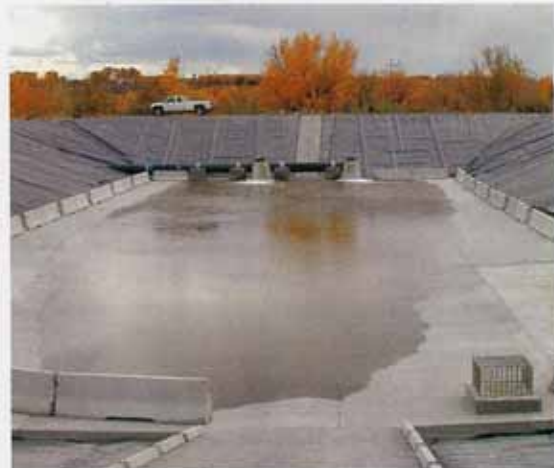
**Photo 1.** The completed access ramp and base clear the way for the geosynthetic redesign of the structure.

To allow the water district access to the interior of the reservoir for clean out, a concrete ramp and base slab were placed on the liner system. A 12 oz nonwoven was used as a cushion between the concrete and the underlying liner. This also provided for drainage from beneath the concrete access system. The access ramp into the reservoir bottom is supported by both adequate interface frictions in the underlying liner system and from buttressing by the concrete base slab. **Photo 1** shows the completed concrete access ramp and base. Note that "Jersey" style barriers were incorporated at the perimeter of the concrete base liner to protect the exposed HDPE side slope liner from damage during future sediment clean out operations.

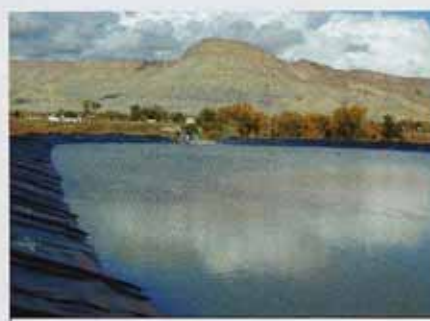
**Photo 2.** The rehabilitated reservoir is finally able to begin serving the water district.

Reconstruction of the reservoir began in late July 2002 by Nielsons SKANSKA. The liner system was installed by Simbeck & Associates. Redesign, construction oversight and CQA for the rebuild was provided by Red Mesa Consulting Inc. Construction was completed in early November 2002. The rebuild of the impoundment cost the water district approximately \$534,000. The Colorado State Engineer's Office granted acceptance of construction on 10 January 2003. **Photo 2** shows the reservoir full and in service today.

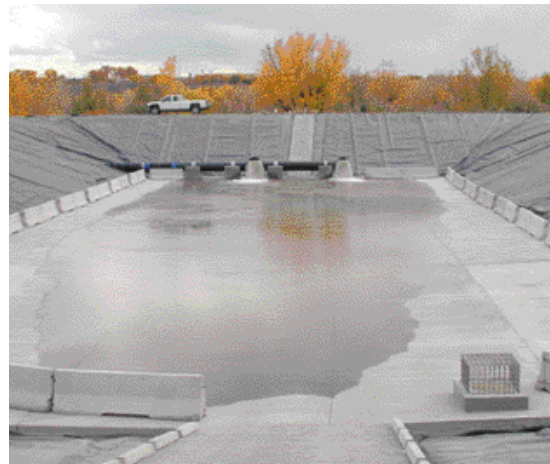
**Photo 1.** The completed access ramp and base clear the way for the geosynthetic redesign of the structure.

To allow the water district access to the interior of the reservoir for clean out, a concrete ramp and base slab were placed on the liner system. A 12 oz nonwoven was used as a cushion between the concrete and the underlying liner. This also provided for drainage from beneath the concrete access system. The access ramp into the reservoir bottom is supported by both adequate interface frictions in the underlying liner system and from buttressing by the concrete base slab. **Photo 1** shows the completed concrete access ramp and base. Note that "Jersey" style barriers were incorporated at the perimeter of the concrete base liner to protect the exposed HDPE side slope liner from damage during future sediment clean out operations.

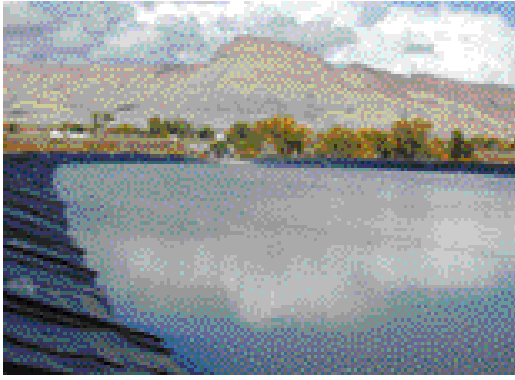
**Photo 2.** The rehabilitated reservoir is finally able to begin serving the water district.

was completed in early November 2002. The rebuild of the impoundment cost the water district approximately \$534,000. The Colorado State Engineer's Office granted acceptance of construction on 10 January 2003. **Photo 2** shows the reservoir full and in service today.
