# SLOPE STABILITY OF GEOSYNTHETIC CLAY LINER TEST PLOTS

By David E. Daniel,<sup>1</sup> Robert M. Koerner,<sup>2</sup> Rudolph Bonaparte,<sup>3</sup> Robert E. Landreth,<sup>4</sup>  
David A. Carson,<sup>5</sup> and Heather B. Scranton<sup>6</sup>

**ABSTRACT:** Fourteen full-scale field test plots containing five types of geosynthetic clay liners (GCLs) were constructed on 2H:1V and 3H:1V slopes for the purpose of assessing slope stability. The test plots were designed to simulate typical final cover systems for landfills. Slides occurred in two of the 2H:1V test plots along interfaces between textured geomembranes and the woven geotextile components of internally reinforced GCLs. One additional slide occurred within the unreinforced GCL component of a 2H:1V test plot, when the GCL unexpectedly became hydrated. All 3H:1V slopes have remained stable. Results of laboratory direct shear tests compared favorably with field observations, providing support for the current design procedures that engineers are using for assessing the stability of slopes containing GCLs.

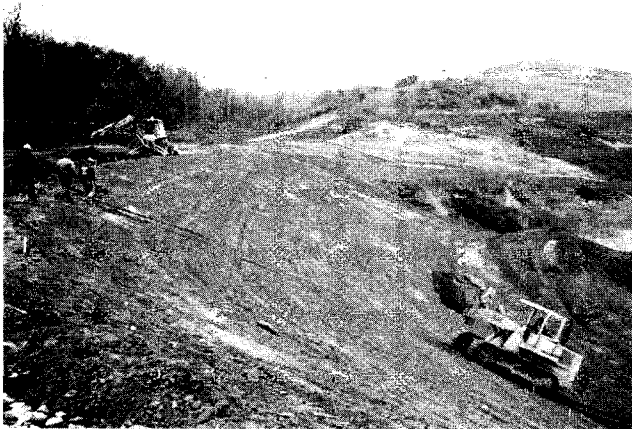
FIG. 6. Graded Surface of 2H:1V Test Plots Prior to Installation of GCLs

The test plots were first graded to provide a smooth subgrade, as shown in Fig. 6. Next, geosynthetics were installed by pulling them down from the crest of the slope (Fig. 7), and then cover soil was placed (Fig. 8) by starting at the bottom of the slope and working upslope. All test plots, except Plot M, were then covered with a geosynthetic erosion control material and seeded with a mixture of grasses.

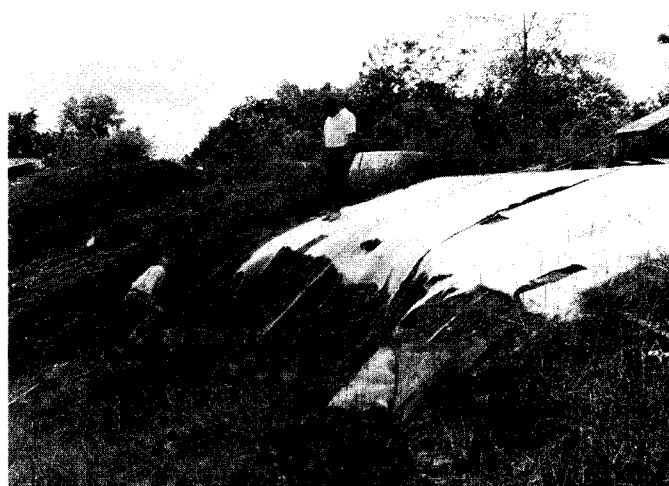
FIG. 17. Photograph of Scarp at Plot I Created by Slide in Subsoil beneath Test Plot

After 2 1/2 years of monitoring, the total downslope movement of Plot I had reached ~170 mm near the toe of the slope, when a slide occurred in the subsoil beneath the GCL (Fig. 17). Excavation into the scarp revealed that the sliding surface was located about 1 m below the GCL and within a wet, plastic clay material. In this case, the GCLs and their interfaces were actually stronger than the native subsoils. Similar failures in foundation soils occurred in nearby plots.

Large displacements have occurred in the foundation soils at Plots I, J, and K, similar to the displacements at Plot I (Fig. 17). The displacements developed in the subsoils beneath the test plots during the wet spring season of 1997. Sliding occurred in some plots, but as shown in Fig. 17, the sliding occurred below the GCLs. Again, the GCLs and their interfaces were stronger than the foundation soils.
