## "GCL SHRINKAGE: A POSSIBLE SOLUTION"

# GCL shrinkage: A possible solution

By Richard Thiel and Chris Thiel

### The Carlota Mine heap leach project

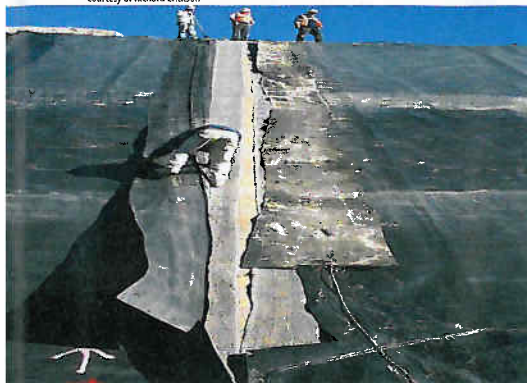
Figure 2 | GCL gap on sideslope in California.

Some of these "failures" have been quite dramatic, with shrinkage gaps up to 3ft between panel after panel of installed GCL, which originally had minimum 6-in. overlaps (**Figure 2-p.11**). Follow-up work reported in *GFR* by Thiel, et al. (2005) and by Thiel, et al. (2006) was able to replicate the GCL shrinkage phenomenon in laboratory tests by the application of cyclic

and magnitude of shrinkage, with asymptotic maximum shrinkage values ranging from approximately zero for geomembrane-supported GCLs, to 25% for a certain double-nonwoven GCL product. That maximum laboratory value, in fact, was approximately representative of the worst-case field exhumation observed in **Figure 2**. Even so, it has been difficult to provide definitive guidance to designers and installers on how to avoid field GCL panel separation due to shrinkage.

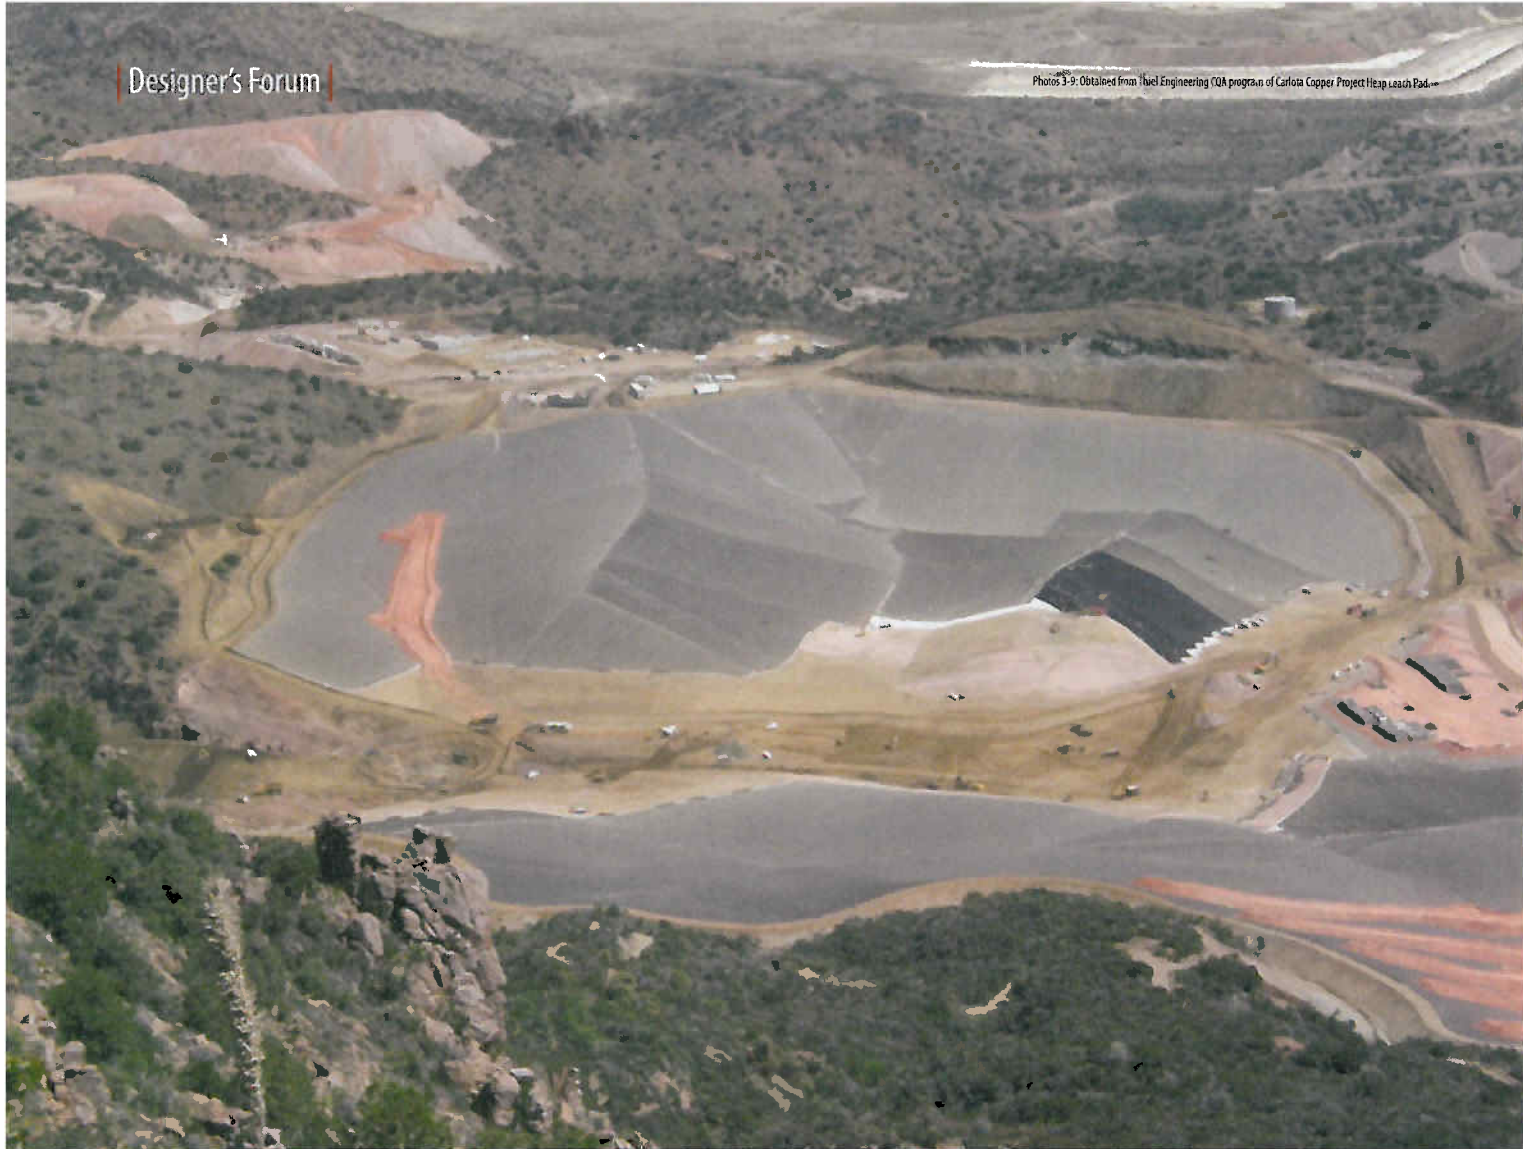
**Figure 3** | The Carlotia Mine heap leach pad under construction with approximately 150 acres of GCL/geomembrane composite liner.

The first phase of the Carlotia Copper Mine heap leach pad comprises a 150-acre lined area. A photograph of the liner installation in progress at this site is shown in **Figure 3**.

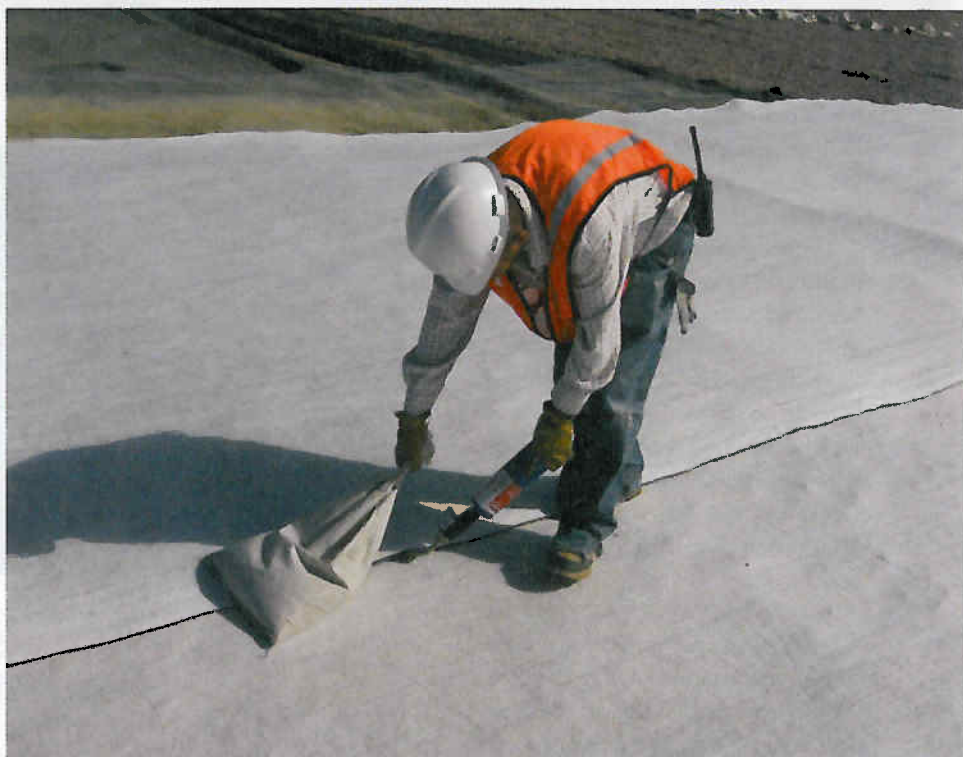
**Figure 4** | Installer flame-tacking GCL edge seam having a 6-in. overlap.

Figures 4-p.12 and 5-p.14 show the installation technician heat-tacking the seam with a torch, followed by a light pressure either by dragging a sandbag over the seam or foot pressure to press the seam together after the torch. The technician could walk along at a steady pace to create the seam; thus the process added negligible material cost (a small amount of propane) and not much labor.

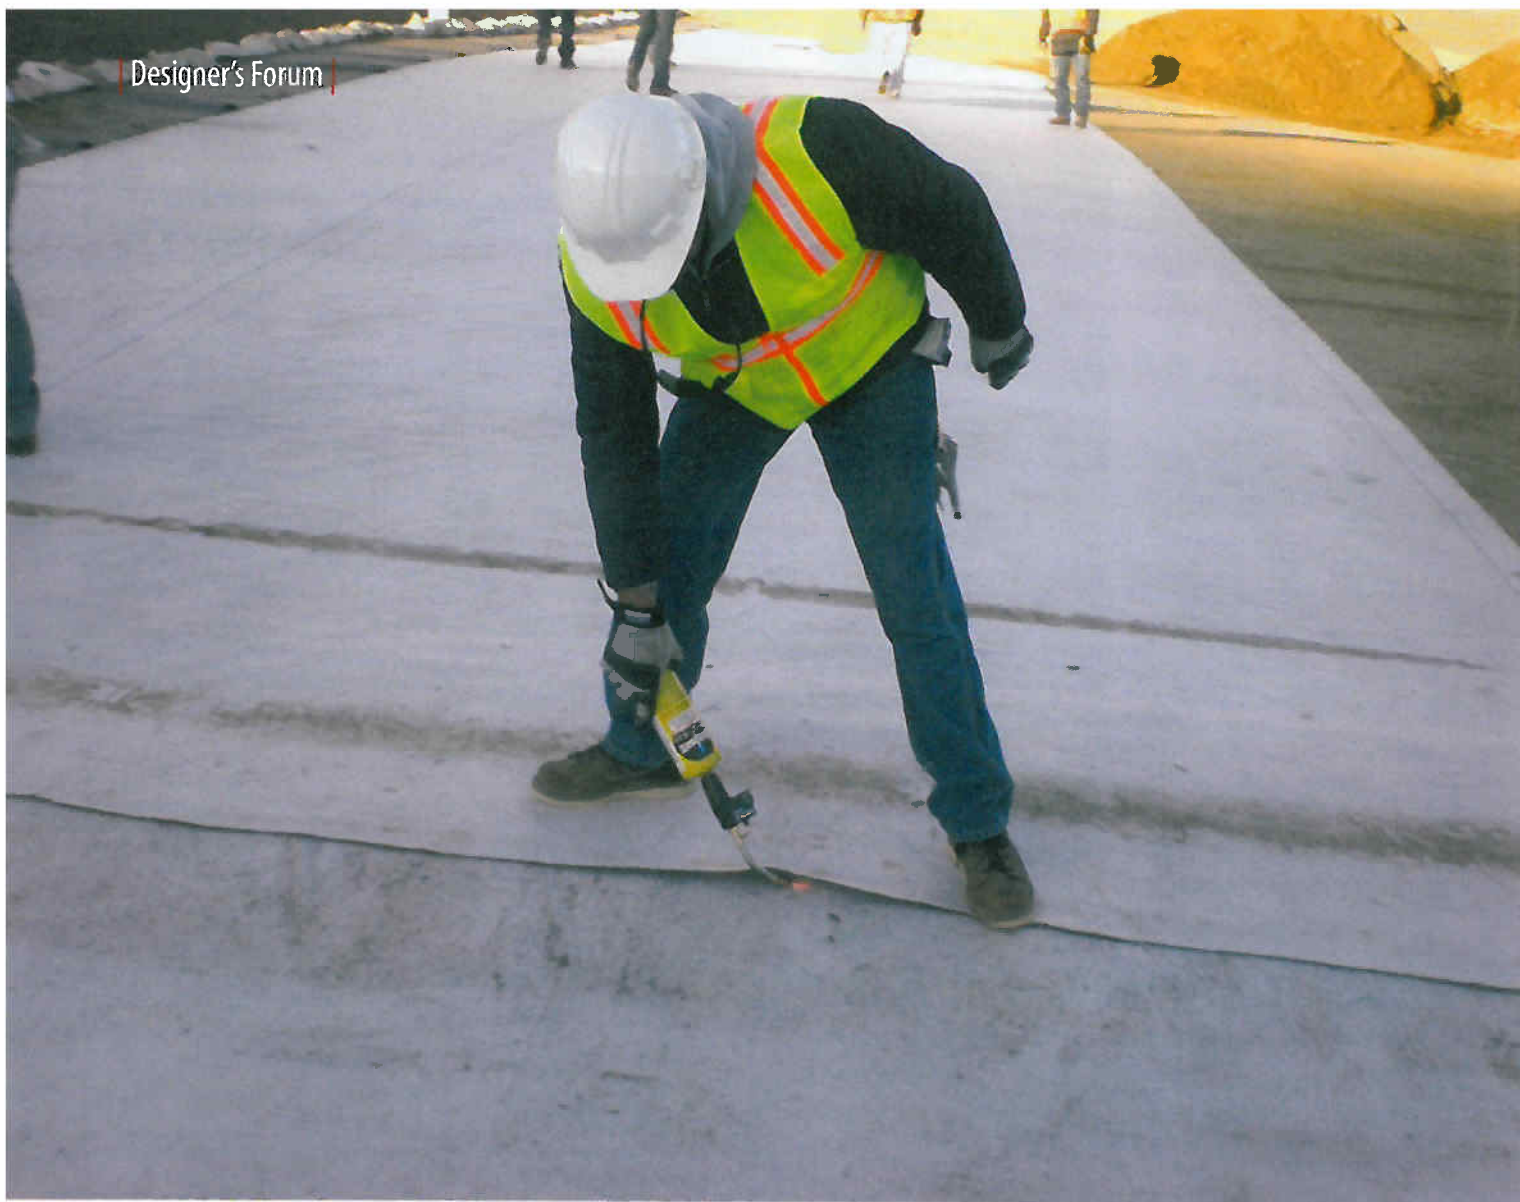
**Figure 5** | Installer flame-tacking GCL butt seam.

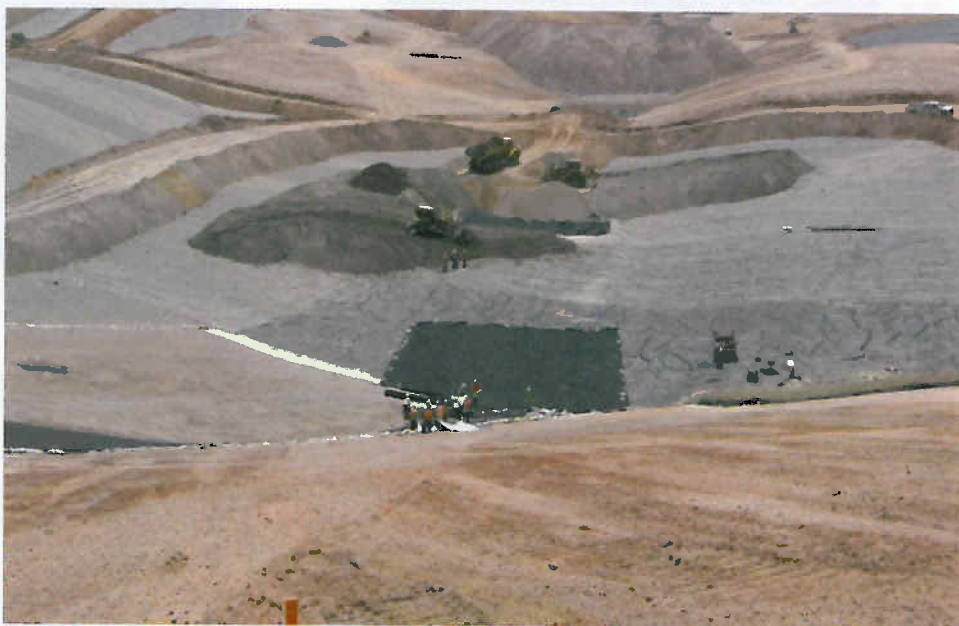
**Figure 6** | Some areas of liner that were unballasted and some areas covered with over-liner material.

During the course of the project, many areas of the 150-acre-lined leach pad went up to, or even exceeded, the 60-day unballasted time frame guideline. Figure 6p.14 shows an example of the large areas of unballasted liner and areas that had overliner during one point of the construction project. To verify that the GCL had not shrunk, the CQA firm cut holes through the geomembrane to exhume the GCL in areas that had been unballasted for more than 60 days.

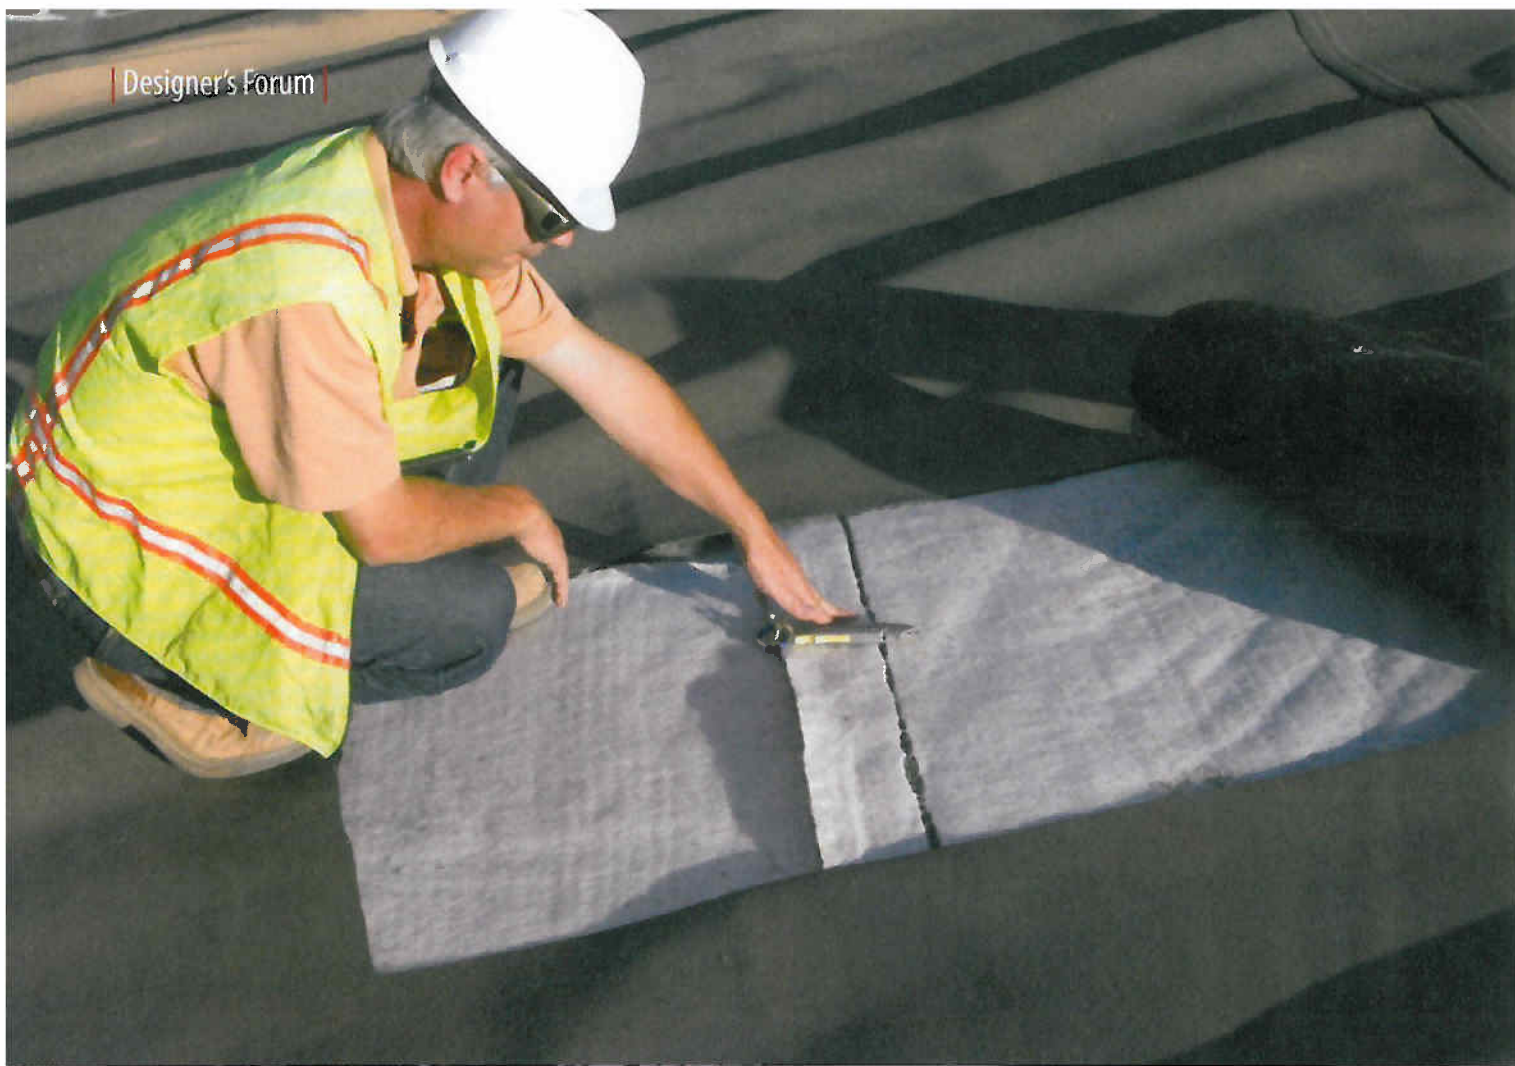
**Figure 7** | Exhumation of GCL overlap on slope that had been unballasted for more than 60 days. The heat-tacked seam was intact.

Figures 7-p.16 and 8-p.18 are photos of some of the areas that were exhumed and sampled. Both the double-nonwoven, and the woven-nonwoven GCL products were evaluated as part of this investigation. In every instance, zero evidence of any GCL shrinkage was noted. The original heat bond of the GCL seam, created by the flame-torch tacking during deployment, was intact in every case.

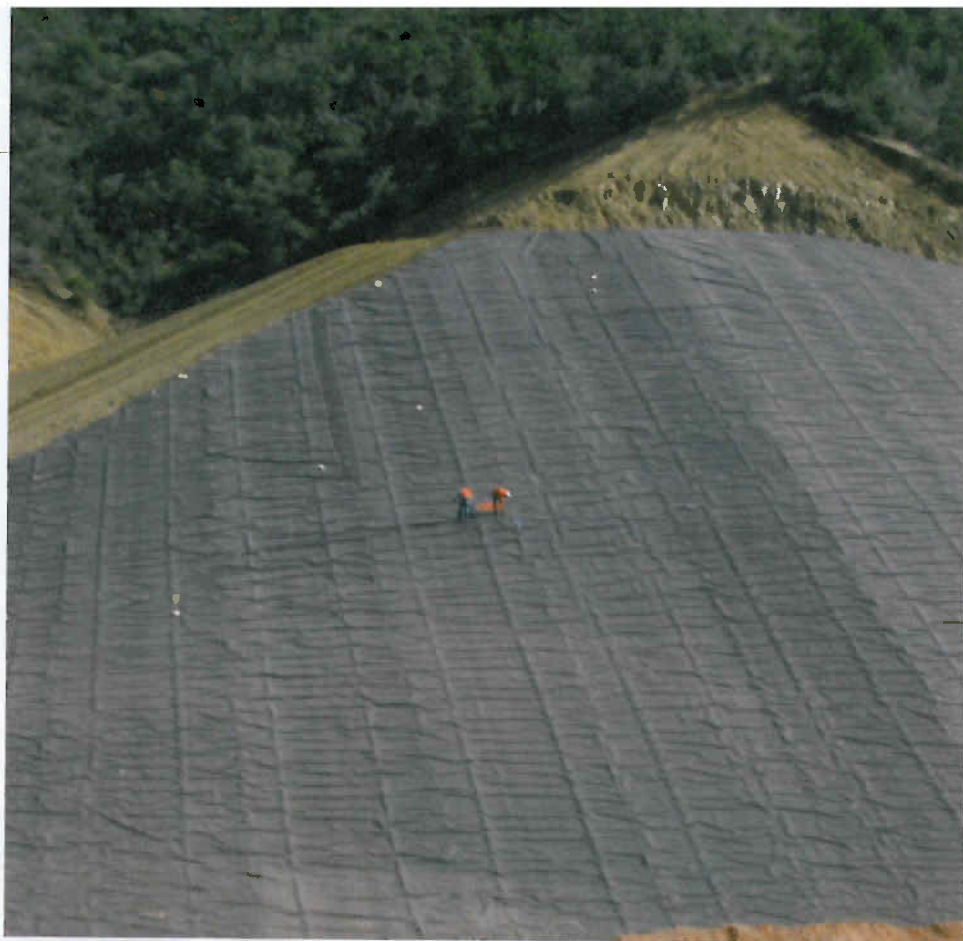
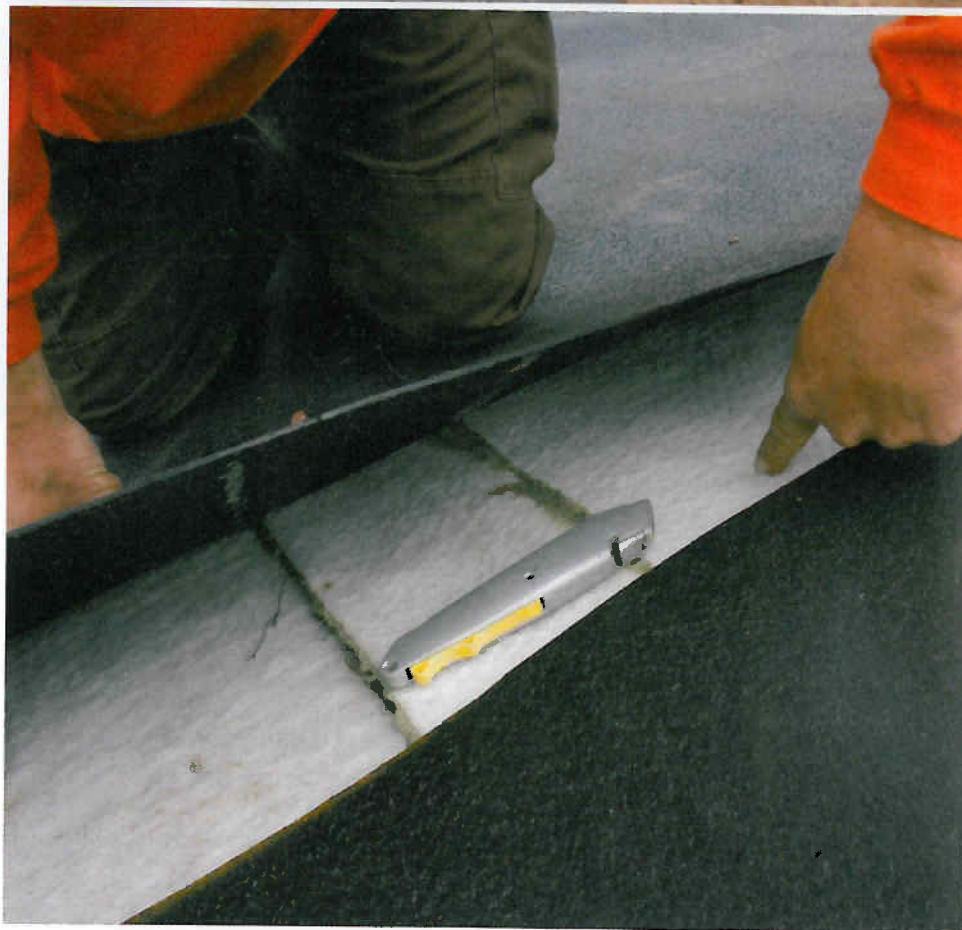
**Figure 8** | Photos showing location on long slope where GCL was exhumed, and the exhumed seam (orange dots in middle of slope are people cutting the geomembrane). GCL was observed to be hydrated, and the heat-tacked seam was intact.

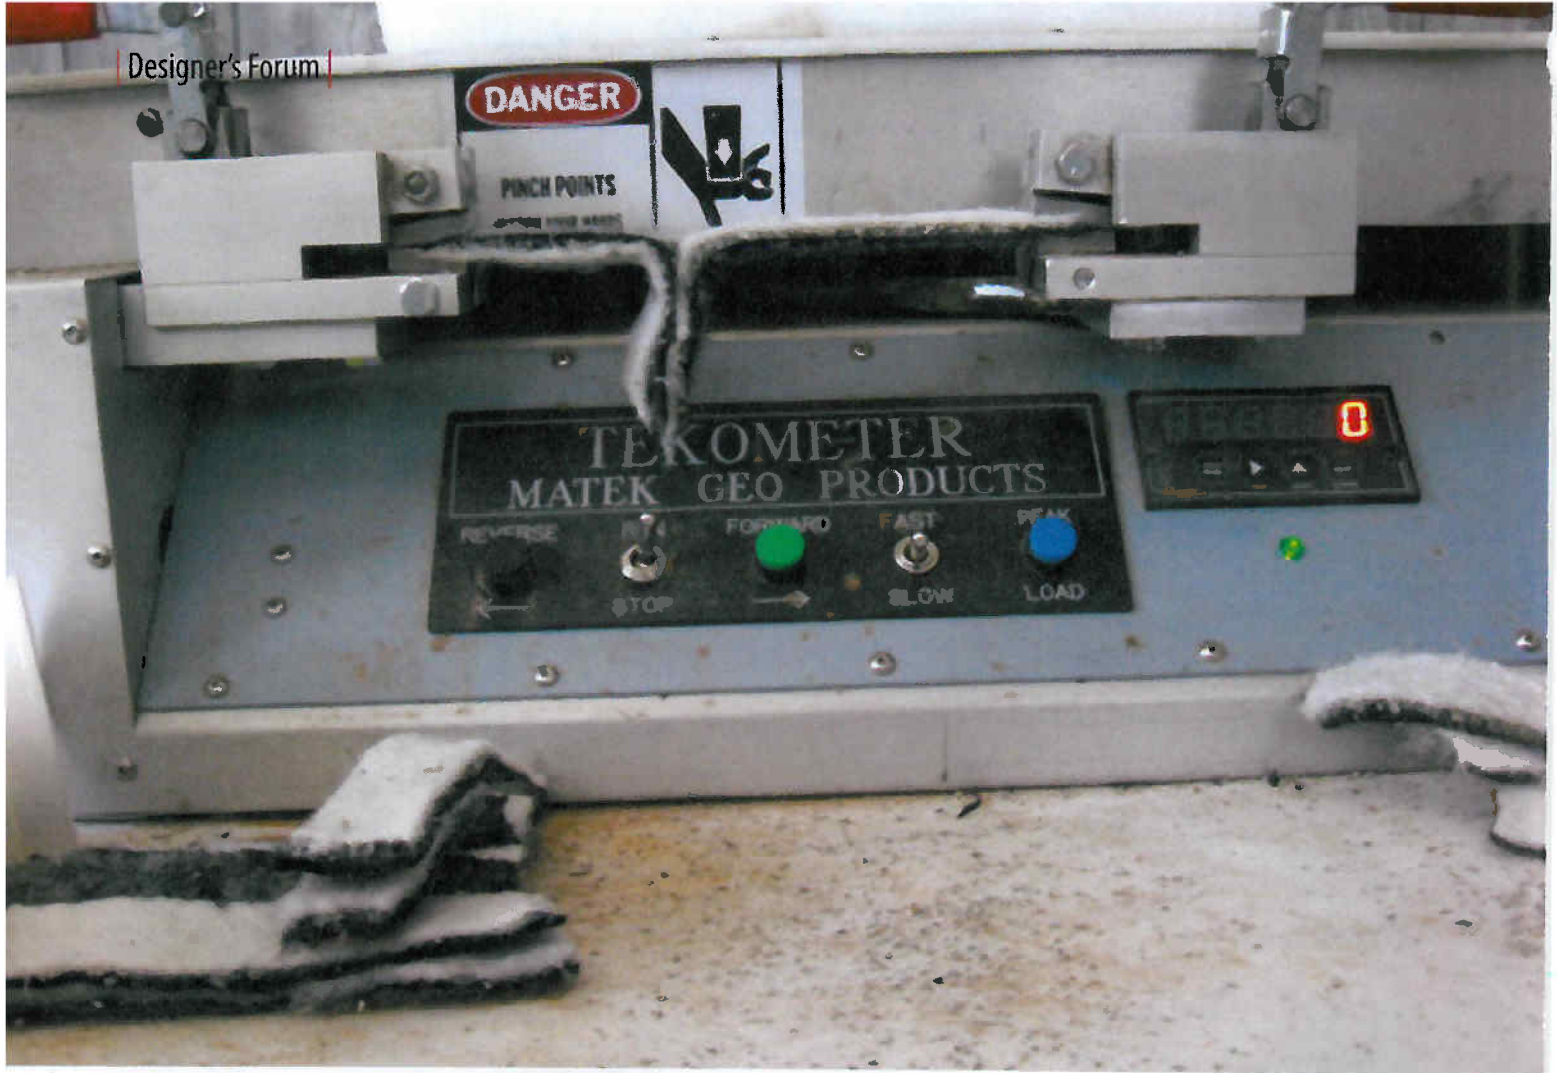
**Figure 9** | Performing shear and peel tests on 1-in. wide strips of heat-bonded GCL seams.

GCL Sample	Seam shear (ppi)	Seam peel (ppi)
Double nonwoven	14	24
	8	18
	18	12
Woven/nonwoven	7	21
	5	21
	4	9

Although there was no specification on the required amount of heat tacking, samples of the heat-tacked GCL seams were cut out and subjected to shear and

peel tests in the field. One-in.-wide samples were razor-cut and tested as if they were geomembrane coupons, as shown in Figure 9, yielding the results in Table 1-p.16.
