DAM REHABILITATION USING GEOSYNTHETIC CLAY LINERS

This paper was presented at the American Society of State Dam Safety Officials '05 Conference.

Jim Olsta, P.E. and Don Carine, CETCO

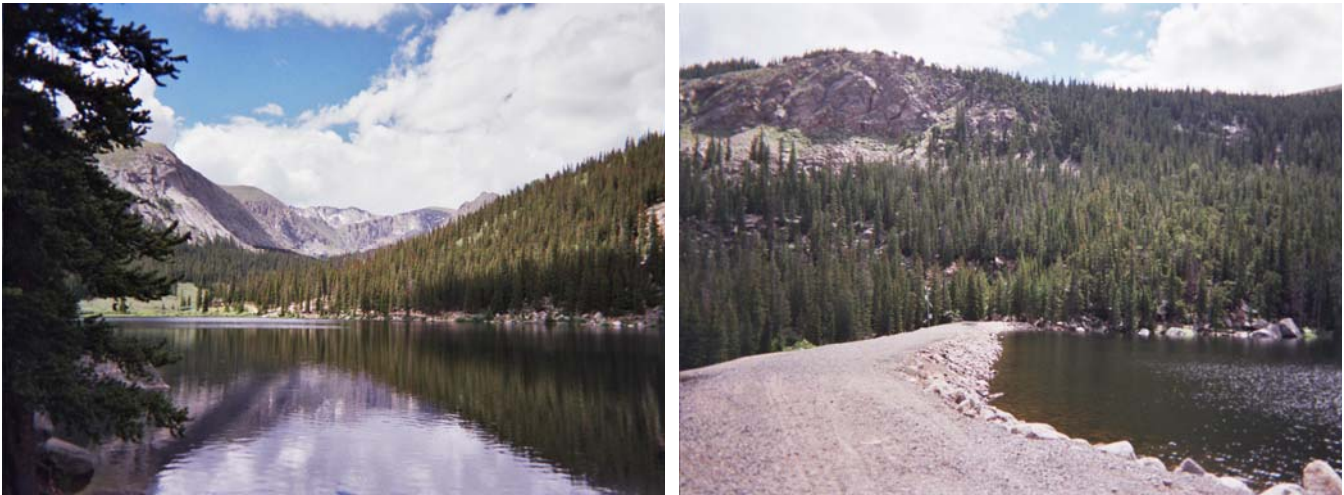
Figures 1a and 1b. Idaho Springs Reservoir and Dam.

The Idaho Springs Reservoir (Figure 1) is located on the eastern front of the Rocky Mountains, 40 miles west of Denver, Colorado. Its primary function is to provide water supply storage for the City of Idaho Springs, Colorado and the surrounding service areas. Built in the early 1900s, an earthen dam controls flooding and protects camp sites and recreation areas in the valley below. By 2000, the Office of the State Engineer, Dam Safety Branch, had placed restrictions on the reservoir's capacity due to the deteriorated condition of the dam and evidence of significant seepage. Prior to the lining project, five significant seepage locations were observed on the downstream side of the dam. One seep exited onto the berm road at the downstream toe (Figure 2) and there was standing water

around an observation well located just downstream of the dam. The reservoir capacity is 270 acre-feet at the crest of the spillway, however, water storage was limited to just 120 acre-feet because of the excessive dam embankment seepage.
