FIELD STUDY OF INSTALLATION DAMAGE FOR GEOSYNTHETIC CLAY LINERS

Technical Paper by P.J. Fox, E.J. Triplett, R.H. Kim and J.T. Olsta

REFERENCE: Fox, P.J., Triplett, E.J., Kim, R.H. and Olsta, J.T., 1998, "Field Study of Installation Damage for Geosynthetic Clay Liners", *Geosynthetics International*, Vol. 5, No. 5, pp. 491-520.

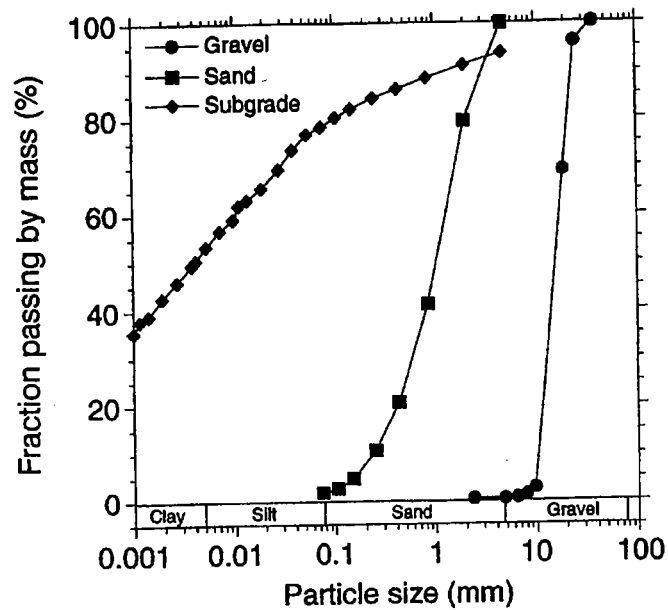
Figure 1. Particle size distributions for subgrade and cover soils.

Figure 1 shows the particle size distributions for the subgrade and two cover soils used to construct the test plots. The subgrade had a liquid limit of 45, plastic limit of 26, and is classified as CL (lean clay with sand) according to the Unified Soil Classification System. The cover soils were clean and cohesionless and were classified as SP (poorly graded sand) and GP (poorly graded gravel). Both cover soils were obtained from a local quarry and were composed of crushed granite with sharp angular particles.

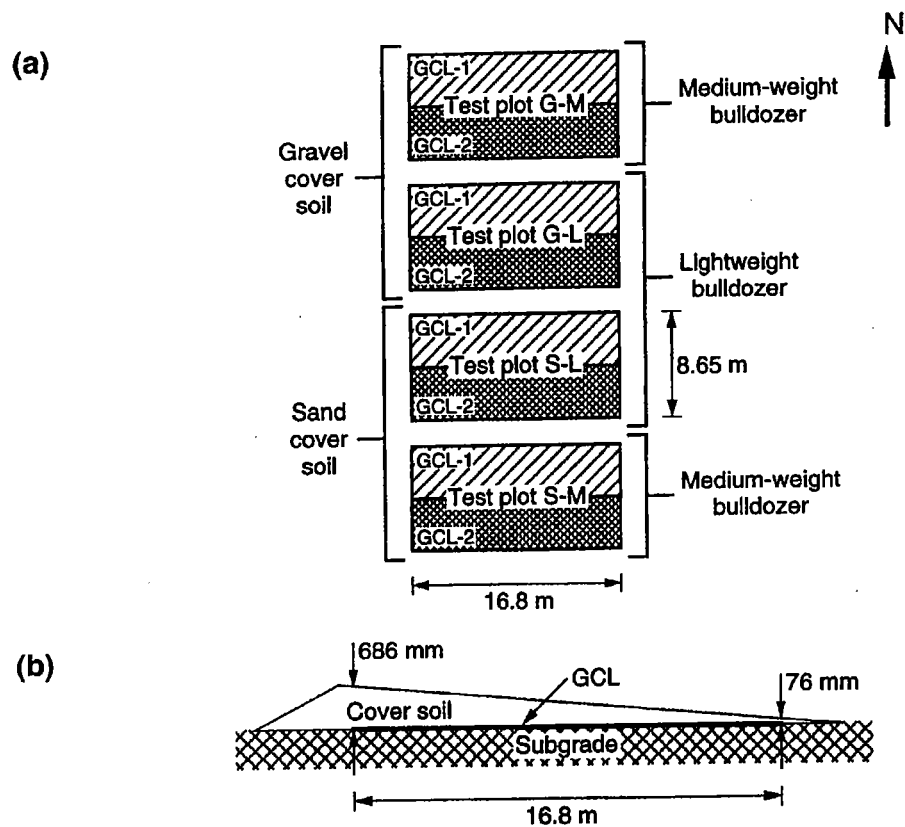
Figure 2. Test site: (a) plan view; (b) cross section.

The study was conducted behind the CETCO manufacturing plant located in Fairmount, Georgia, USA, over a two week period in August 1997. The test site is shown schematically in Figure 2. The subgrade was prepared by scraping the grass and topsoil off the site and rolling the surface at natural water content (10 to 15%) with a 108 kN smooth drum roller. Prior to GCL installation, the subgrade met the criteria of ASTM D 6102. A sand cone test of the prepared subgrade yielded a dry unit weight of 16.7 kN/m^3 , which is slightly higher than the corresponding standard Proctor maximum dry unit weight of 16.5 kN/m^3 for this soil.

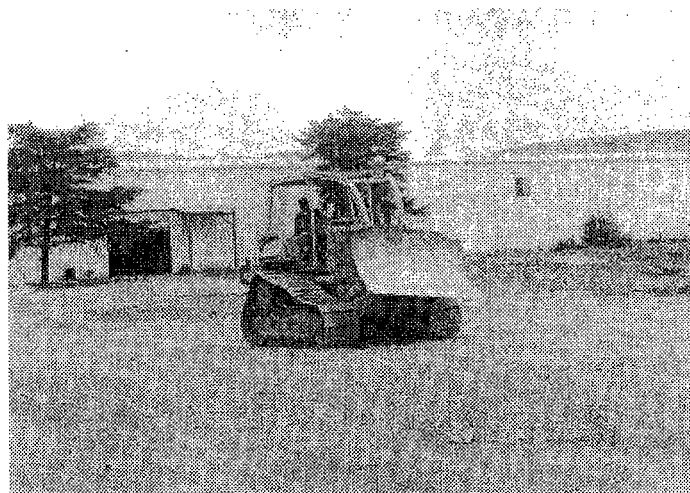
Figure 3. GCL trafficking for test plot G-M.

On 11 August, the Caterpillar D5H-XL bulldozer was driven over test plots S-M and G-M in the same manner as was done previously for plots S-L and G-L. Figure 3 shows the medium-weight bulldozer driving over test plot G-M.

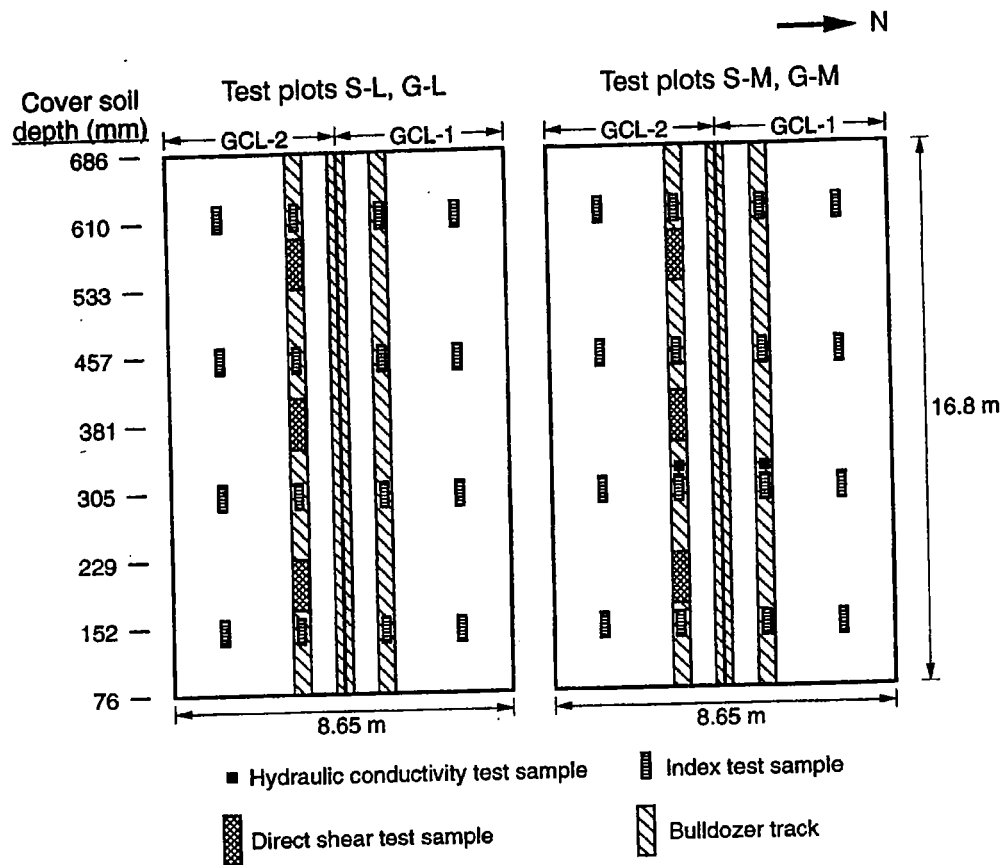
Figure 4. Locations of the exhumed GCL samples.

Exhumation of GCL samples from each test plot began immediately after bulldozer trafficking was completed. A total of 80 GCL samples were collected for laboratory testing, the locations of which are shown in Figure 4. For each GCL panel, two samples ($0.3 \text{ m} \times 0.5 \text{ m}$) were exhumed for index tests at cover soil depths, H , of 152, 305, 457, and 610 mm, one sample directly underneath the bulldozer track, and one approximately 1.5 m away from the bulldozer track (Figure 5). Three large GCL-2 samples ($0.5 \text{ m} \times 1.5 \text{ m}$) were collected for direct shear tests from each test plot under the bulldozer track at average depths of 203, 381, and 559 mm. The direct shear samples were cut with the long sides parallel to the product machine direction. In addition, two samples of GCL-1 and two samples of GCL-2 ($0.2 \text{ m} \times 0.2 \text{ m}$) were collected, at a depth of 330 mm under the bulldozer tracks, from test plots S-M and G-M for hydraulic conductivity tests.

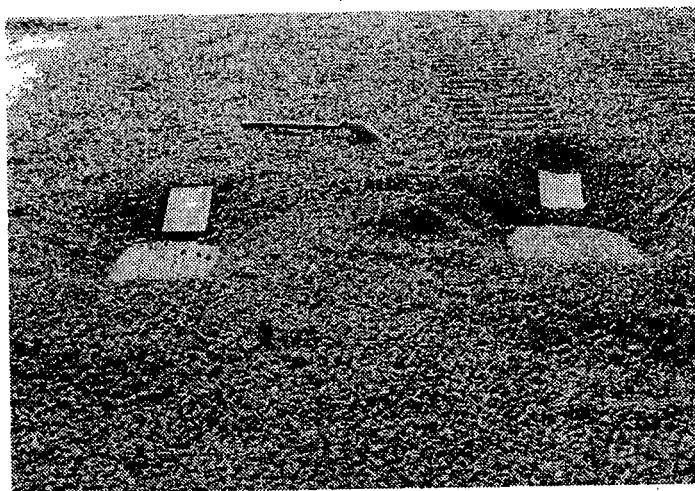
Figure 5. Exhumed GCL-2 specimens under the bulldozer track and 1.5 m away from the bulldozer track for test plot G-M ($H = 152$ mm).

Figure 12b shows μ values for GCL-1 with 10 passes after hydration. Values for S-L, G-L, and S-M reveal no clear trends, whereas values for G-M decrease significantly with decreasing cover soil thickness. Upon exhumation of the G-M specimens, severe bentonite migration was observed for $H = 152$ mm. In this case, bentonite extruded vertically through the upper geotextile into the gravel layer, with the upper geotextile remaining intact. At some locations, the geotextiles of GCL-1 were in contact and, once the gravel particles were carefully picked away, the underlying subgrade could be seen through the geotextiles. G-M specimens of GCL-1 showed progressively less vertical bentonite migration for thicker cover soil layers. Compared to the control specimens, the percent reduction in μ for the G-M specimens is 81, 42, 12, and -10% for $H = 152$, 305, 457, and 610 mm, respectively. Specimens of GCL-1, when covered with clean angular gravel and subjected to 10 passes of the medium-weight bulldozer after hydration, failed for $H = 152$ mm and 305 mm. Values of μ are not significantly reduced for $H = 457$ mm and 610 mm.

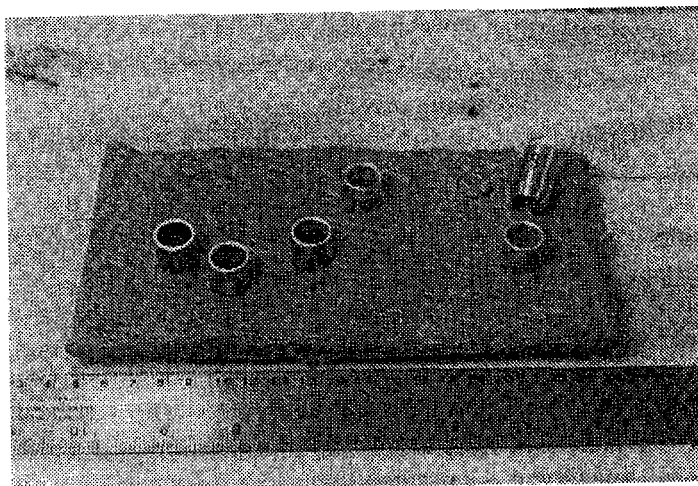
Figure 6. Sampling local bentonite mass per unit area using miniature tubes.

A detailed procedure was used to measure the distributions of local thickness and local μ values for the second specimen. Three "thick" and three "thin" locations were identified by manual inspection. If no perceptible differences in thickness could be found, six arbitrary locations were selected. Six thickness measurements were obtained at these locations using a caliper with C-shaped jaws. At the same locations, six measurements of local μ were obtained using miniature sampling tubes (Figure 6). Each tube consisted of a thin-walled, stainless steel or brass cylinder (diameter = 10 mm, height = 25 mm), which was sharpened at one end. To penetrate the geotextiles without squeezing the bentonite, an auxiliary tube was heated with a propane torch and used to melt a circular ring through the top geotextile (but not through the clay) at the six loca-

tions. The sampling tubes were then pushed into the bentonite, the GCL specimen was turned over, and the auxiliary tube was again used to melt the bottom geotextile such that each tube could be removed with a small specimen of the GCL inside. The tubes were then placed in moisture content tins and oven dried overnight. Knowing the tare weight and cross-sectional area of each tube, six values of local mass per unit area were obtained for each GCL specimen. Control specimens from each roll were slightly hydrated and subjected to the same procedure.

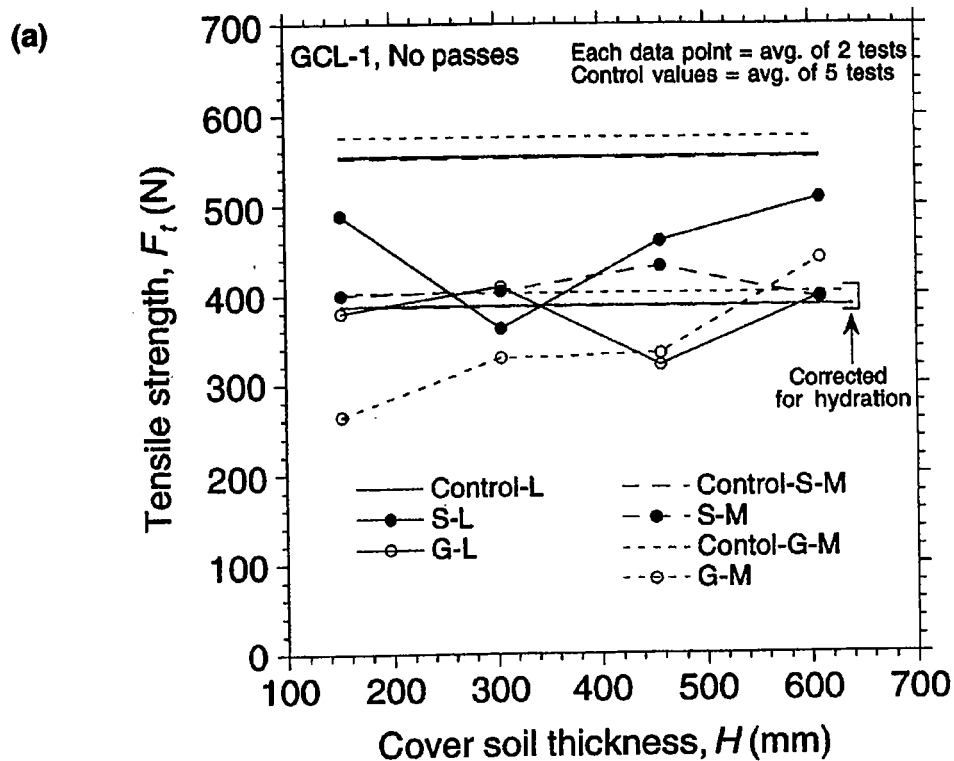
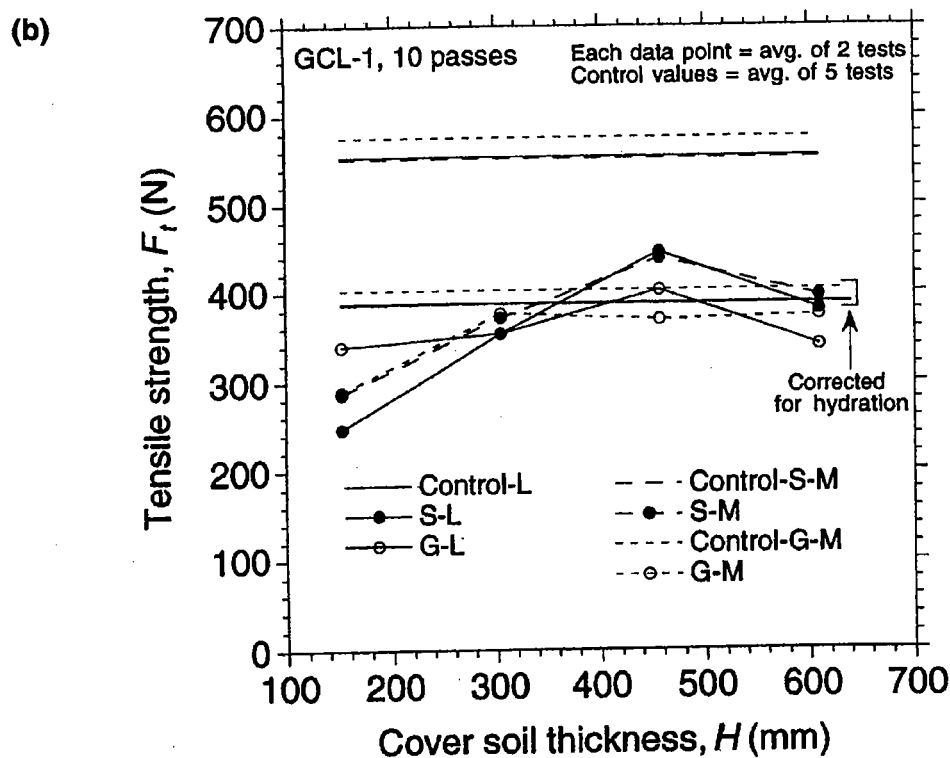
Figure 7. Grab tensile strength of GCL-1 for: (a) no passes; (b) 10 passes after hydration.

Grab tensile strengths for GCL-1 and GCL-2 are plotted in Figures 7 and 8, respectively. Values for the control specimens, which are independent of H , are shown as horizontal lines. Each data point represents the average of two tests and each control value represents the average of five tests. Although the data in these plots (and the ones to follow) show significant scatter, some trends are evident. The average measured tensile strength for nearly every pair of field specimens is significantly less than that of the corresponding control specimens. However, for several test series (e.g. GCL-1, G-M, 10 passes), F_t shows relatively small variation for $H = 305$ mm. In addition, visual inspection of the specimens exhumed from deeper cover soils revealed no perceptible damage to the carrier geotextiles of either GCL product. It is therefore concluded that the reduced values of F_t resulted, at least in part, from the different hydration condition of the field and control specimens. Compared to the control specimens, the hydrated field specimens were thicker, softer, and covered with a thin layer of moist bentonite. As a result, a higher clamping pressure was needed for the testing grips to prevent the field

In a subsequent series of tests performed on 30 specimens, grab tensile strengths of GCL-1 and GCL-2 were reduced after hydration in the laboratory for two days under a normal stress of 3 kPa. The average tensile strength decreased by 30% for GCL-1 (average $w = 245\%$) and 9% for GCL-2 (average $w = 113\%$). Grab tensile strength values for the control specimens were corrected for hydration using these results as a guideline. The corrected values, also shown in Figures 7 and 8, are in closer agreement with the field data.

Figures 7a and 8a suggest that F_t values for the S-L, G-L, and S-M specimens of both GCL products with no bulldozer passes after hydration does not significantly decrease as a result of installation. Considering that essentially no reductions were measured for $H = 152$ mm, differences between field and corrected control values likely reflect product variability. For the G-M specimens at $H = 305$ mm, F_t decreases by 18% for GCL-1 and -1% for GCL-2. Corresponding decreases at $H = 152$ mm are 34% for GCL-1 and 12% for GCL-2. These reductions are attributed to installation damage.

Grab tensile strengths of field specimens that received 10 passes after hydration are shown in Figures 7b and 8b. The plots suggest the carrier geosynthetics of GCL-1 experienced minimal damage for $H = 305$ mm. GCL-2 follows a similar trend with the exception of G-M, which showed F_t reductions of up to 20%. For $H = 152$ mm, F_t has the lowest value for each test series. The maximum reduction in tensile strength is approximately 34% for both GCL products, which is consistent with typical strength reduction factors of 1.1 to 1.5 for the installation of geotextiles in slope stabilization applications (Koerner 1998).

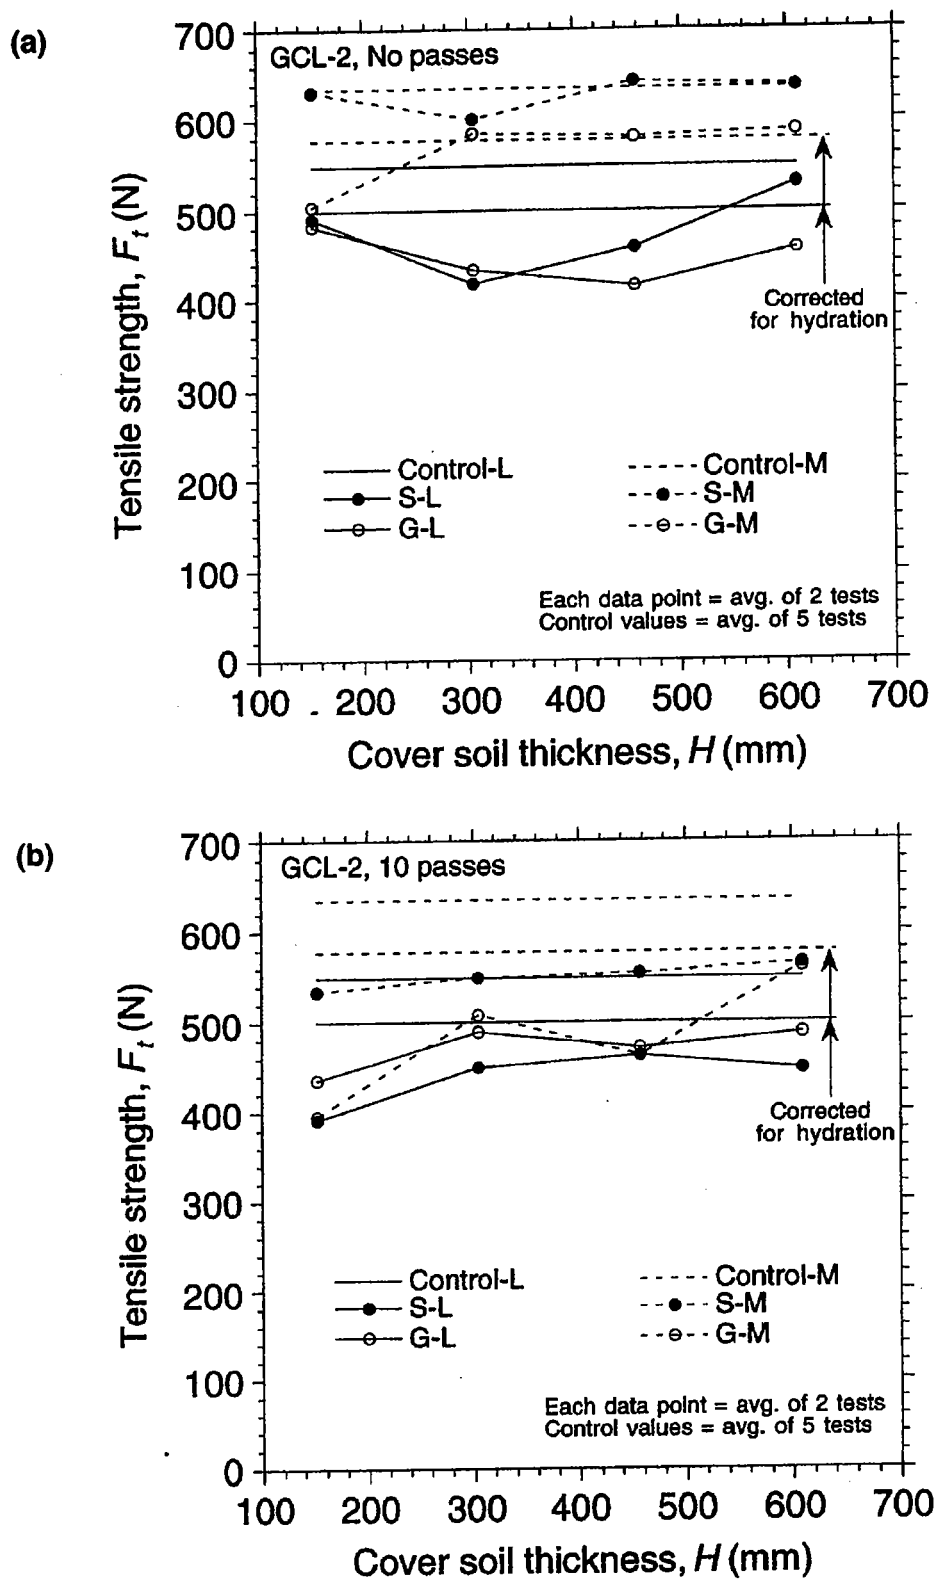
Figure 8. Graph tensile strength of GCL-2 for: (a) no passes; (b) 10 passes after hydration

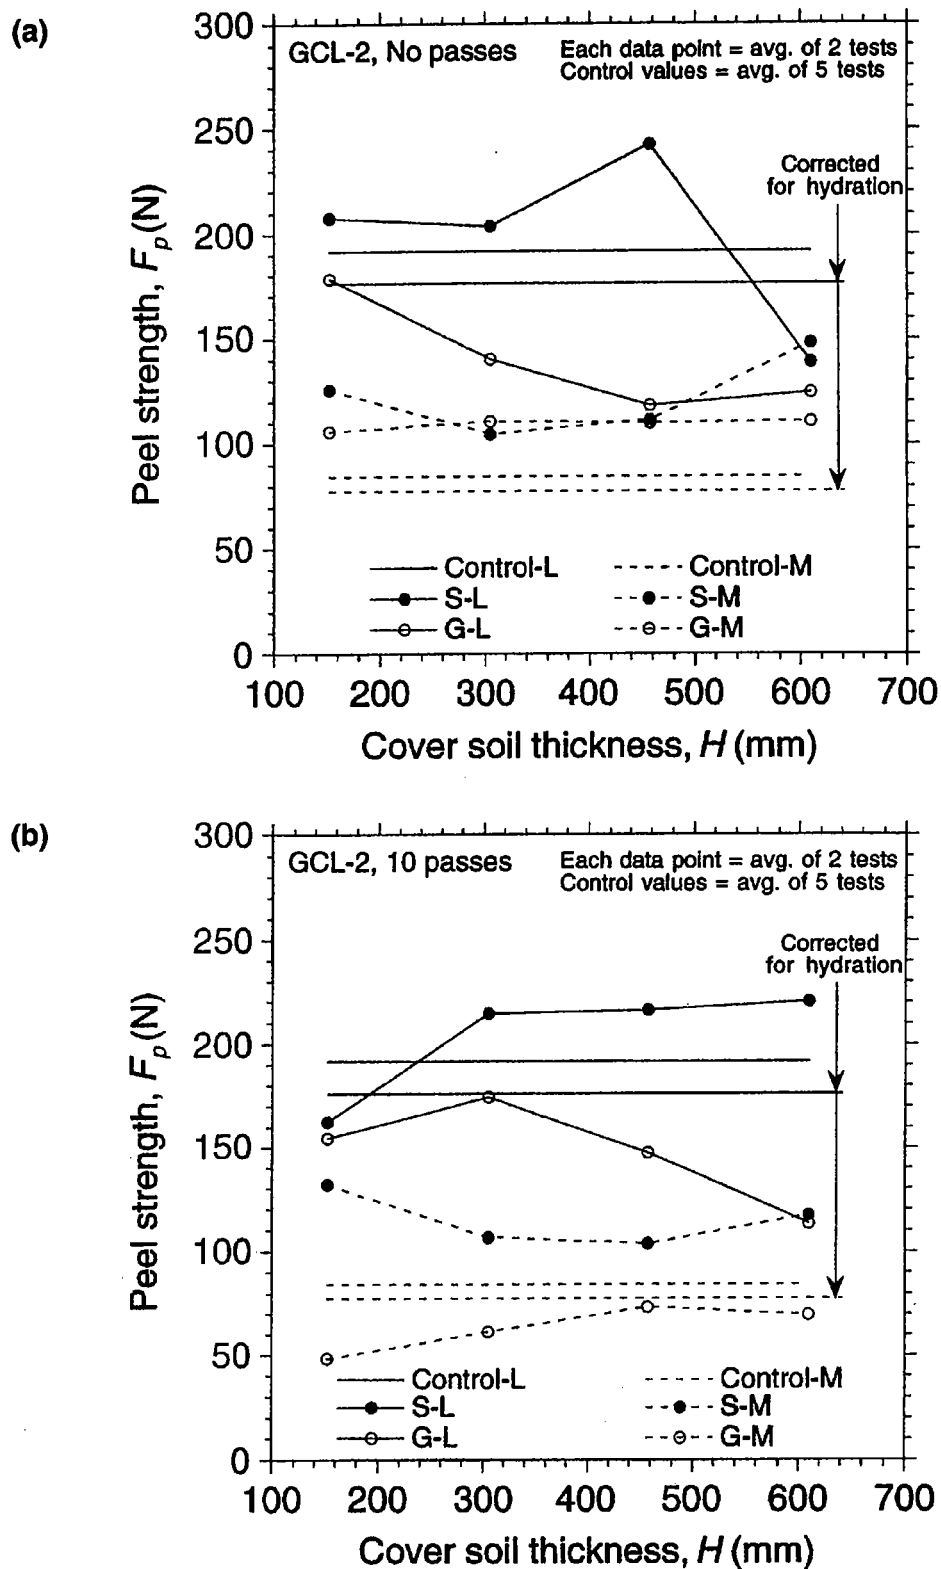
Figure 9. Grab peel strength of GCL-2 for: (a) no passes; (b) 10 passes after hydration.

Grab peel strengths of GCL-2 specimens are presented in Figure 9. A subsequent series of tests performed on eight GCL-2 specimens showed that F_p was reduced, on average, by 8% after hydration in the laboratory for two days under a normal stress of 3 kPa. Figure 9 also provides control values that were corrected for hydration based on these results. The grab peel strength of field specimens that received no passes after hydration show substantial variability (Figure 9a) but little indication of damage to the reinforcement of GCL-2. Similarly, Figure 9b suggests little reinforcement damage for $H = 305$ mm and 10 passes after hydration. Considering $H = 152$ mm, 10 bulldozer passes reduces the peel strength of GCL-2 (except for S-M) by as much as 38%.

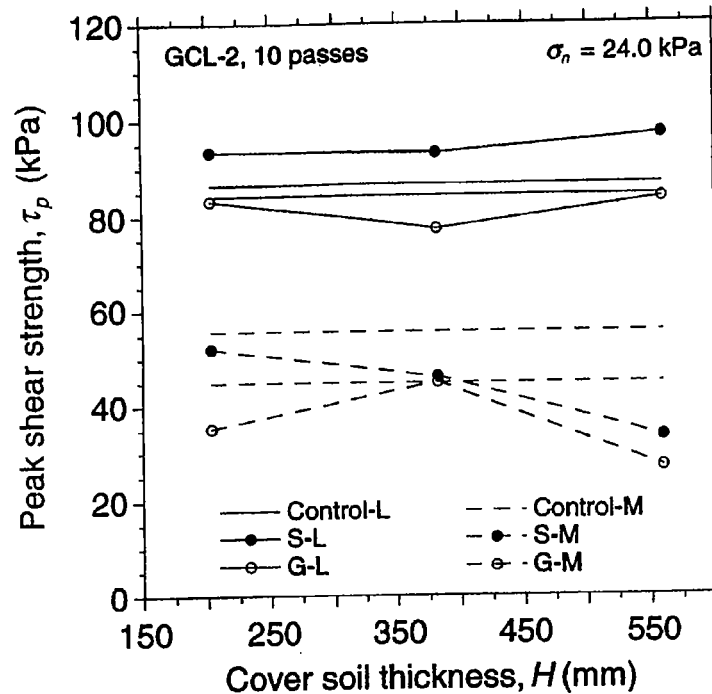
Figure 10. Peak internal shear strength of GCL-2 for 10 passes after hydration.

Figure 10 shows peak internal shear strengths, τ_p , for GCL-2 specimens. Compared to the plots for tensile and peel strength, the data in Figure 10 exhibit less variability, possibly because of the large size of the direct shear test specimens. Similar to previous studies of GCL-2 (Gilbert et al. 1996; Fox et al. 1998), the specimens failed at the woven geotextile/bentonite interface and not within the hydrated bentonite. In addition, mea-

sured values of excess pore pressure on the failure surfaces were small during shear (± 0.7 kPa). Figure 10 indicates that τ_p was not significantly reduced as a result of installation and trafficking. A possible exception is the G-M test at $H = 203$ mm, in which τ_p is 32% less than the corresponding S-M value.

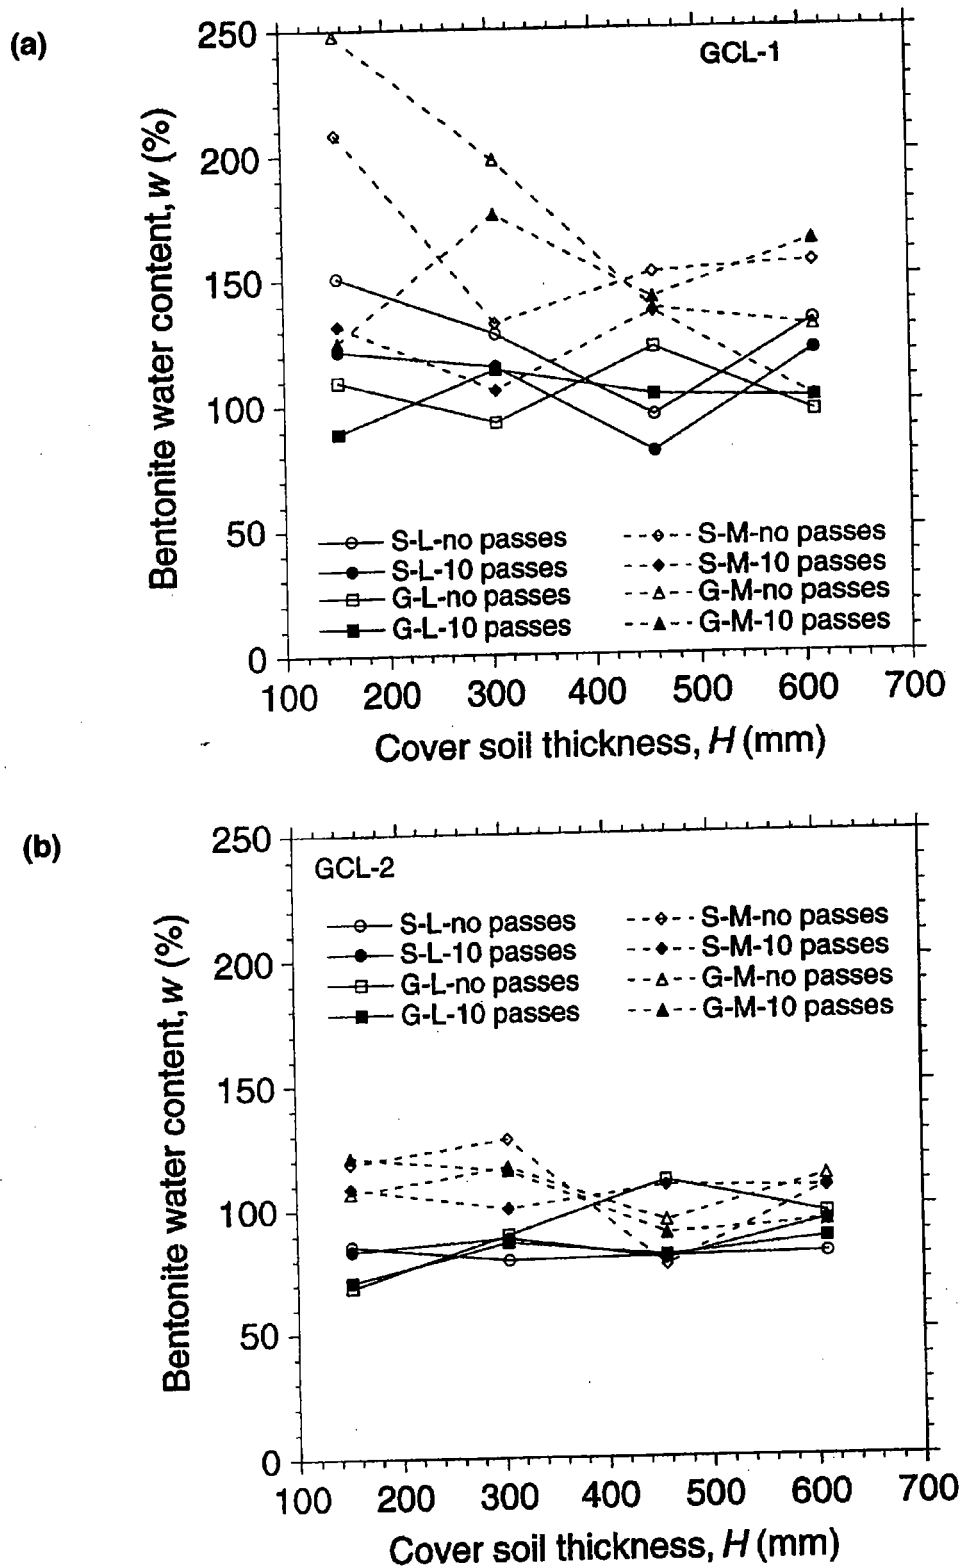
Figure 11. Bentonite water content for: (a) GCL-1; (b) GCL-2.

Bentonite water contents for the 102 mm \times 127 mm field specimens are shown in Figure 11a for GCL-1. Water contents for test plots S-M and G-M are generally higher than those for test plots S-L and G-L, providing direct evidence of the different hydration conditions for the two phases of the current study. In addition, w generally increases with decreasing H due to the lower effective overburden stress. Most GCL-1 specimens that received 10 passes after hydration have a lower water content than corresponding specimens, which received no passes after hydration (especially for $H \leq 305$ mm). This trend cannot be explained by changes in GCL mass per unit area (Figure 12). It may be that, despite the short duration of trafficking, limited consolidation of the bentonite was responsible for the lower measured water contents.

Water contents for GCL-2 (Figure 11b) are more consistent and generally lower than that for GCL-1 due to the additional confinement provided by the needle-punched reinforcement. As H decreases, w generally decreases for the S-L and G-L specimens (due to desiccation) and generally increases for the S-M and G-M specimens (due to lower

overburden stress). No significant difference in w was measured for specimens subjected to zero passes and 10 passes after hydration. Water contents for GCL-2 do not exceed 128%, whereas values as high as 248% were measured for GCL-1 under similar conditions.

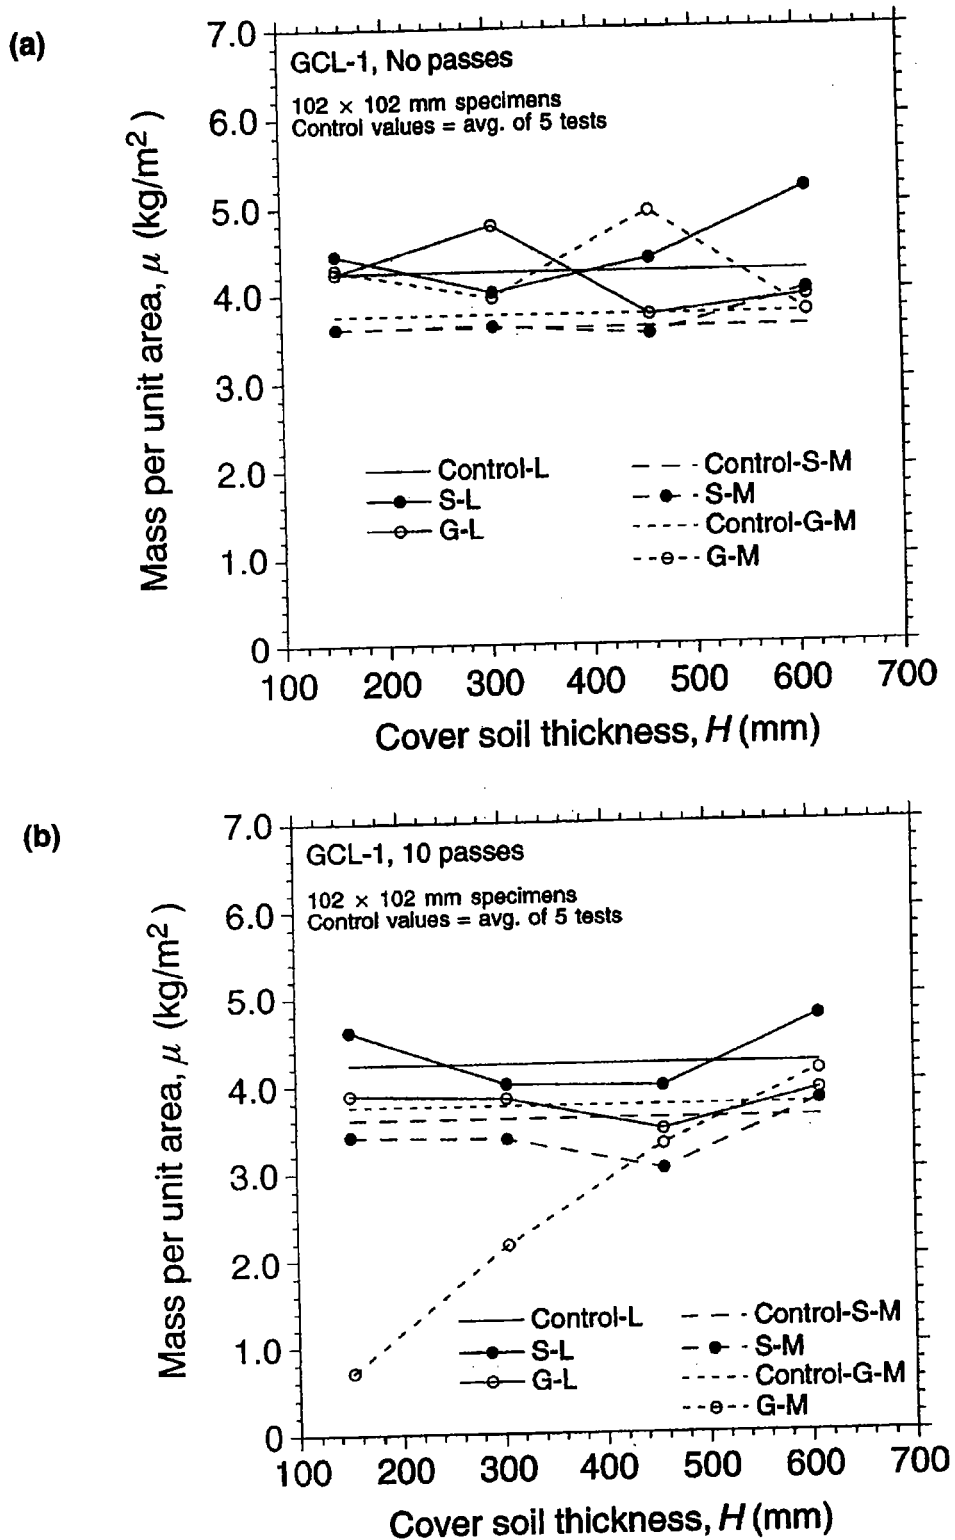
Figure 12. Bentonite mass per unit area values of GCL-1 for: (a) no passes; (b) 10 passes after hydration.

Values of μ for the 102 mm \times 127 mm GCL-1 specimens are shown in Figure 12. With no passes after hydration (Figure 12a), field specimen values are in relatively close agreement with those for the control specimens. No significant variation was found with cover soil type, cover soil thickness, or bulldozer type.

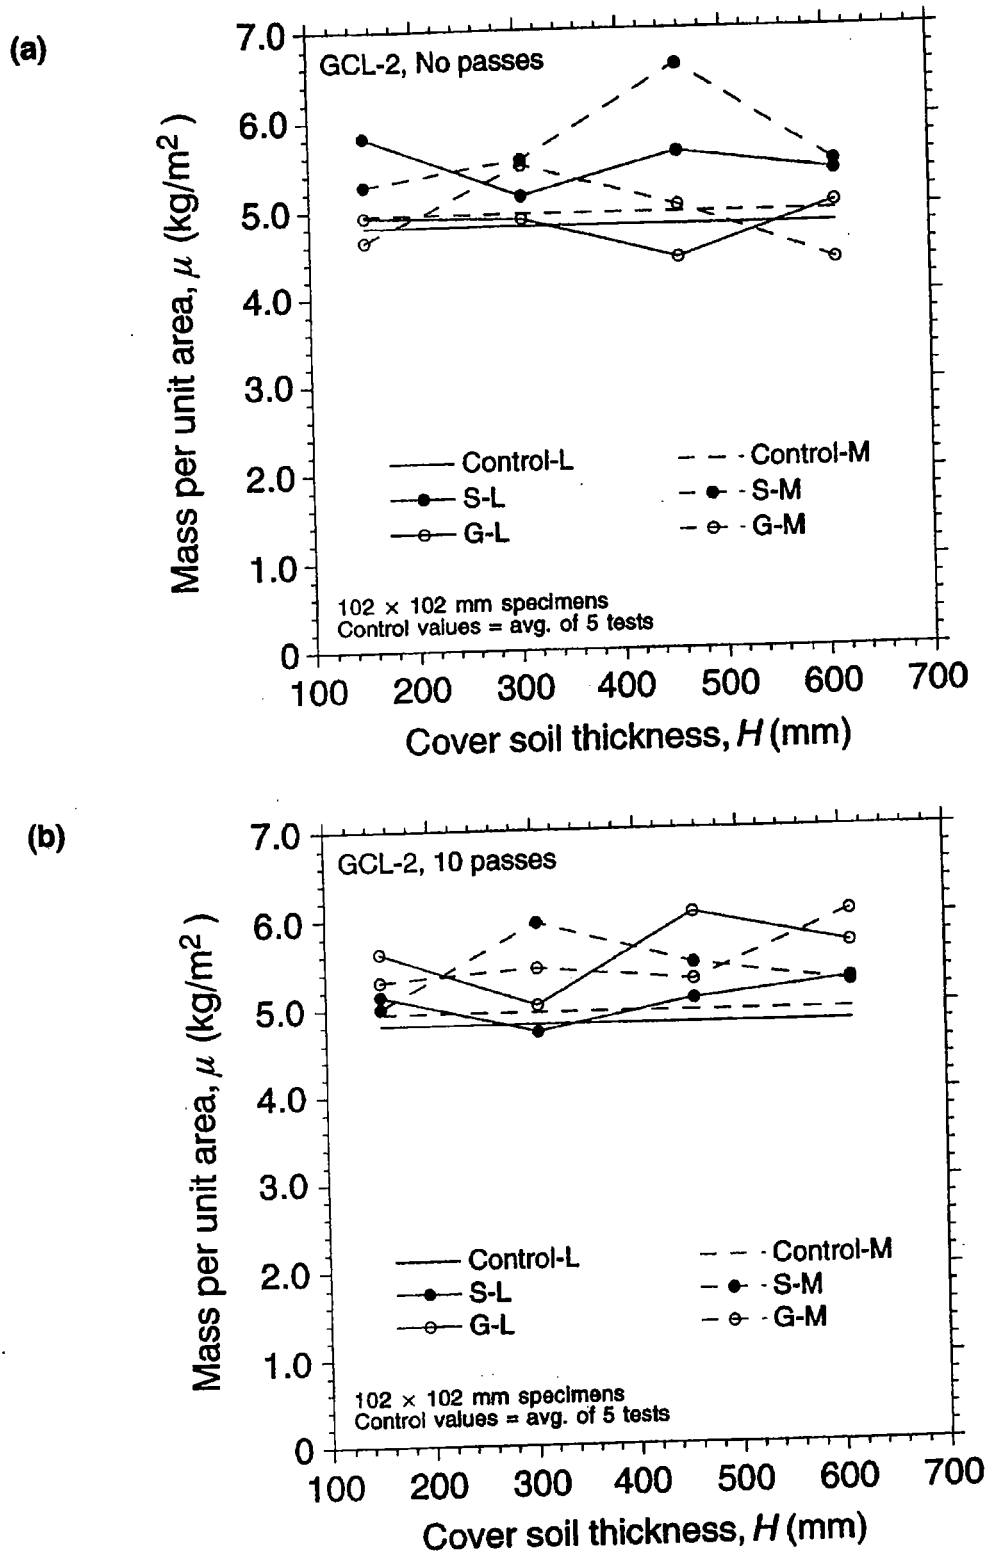
Figure 13. Bentonite mass per unit area values of GCL-2 for: (a) no passes; (b) 10 passes after hydration.

Corresponding plots of μ for field and control specimens of GCL-2 are shown in Figure 13. GCL-2 shows essentially no loss of bentonite for all conditions. On the contrary, values of μ for the field specimens are generally larger than those for the control specimens. This presumably resulted from the difficulty of scraping the cover soil particles out of the woven geotextiles (with protruding needle-punched fibers) prior to drying the specimens.

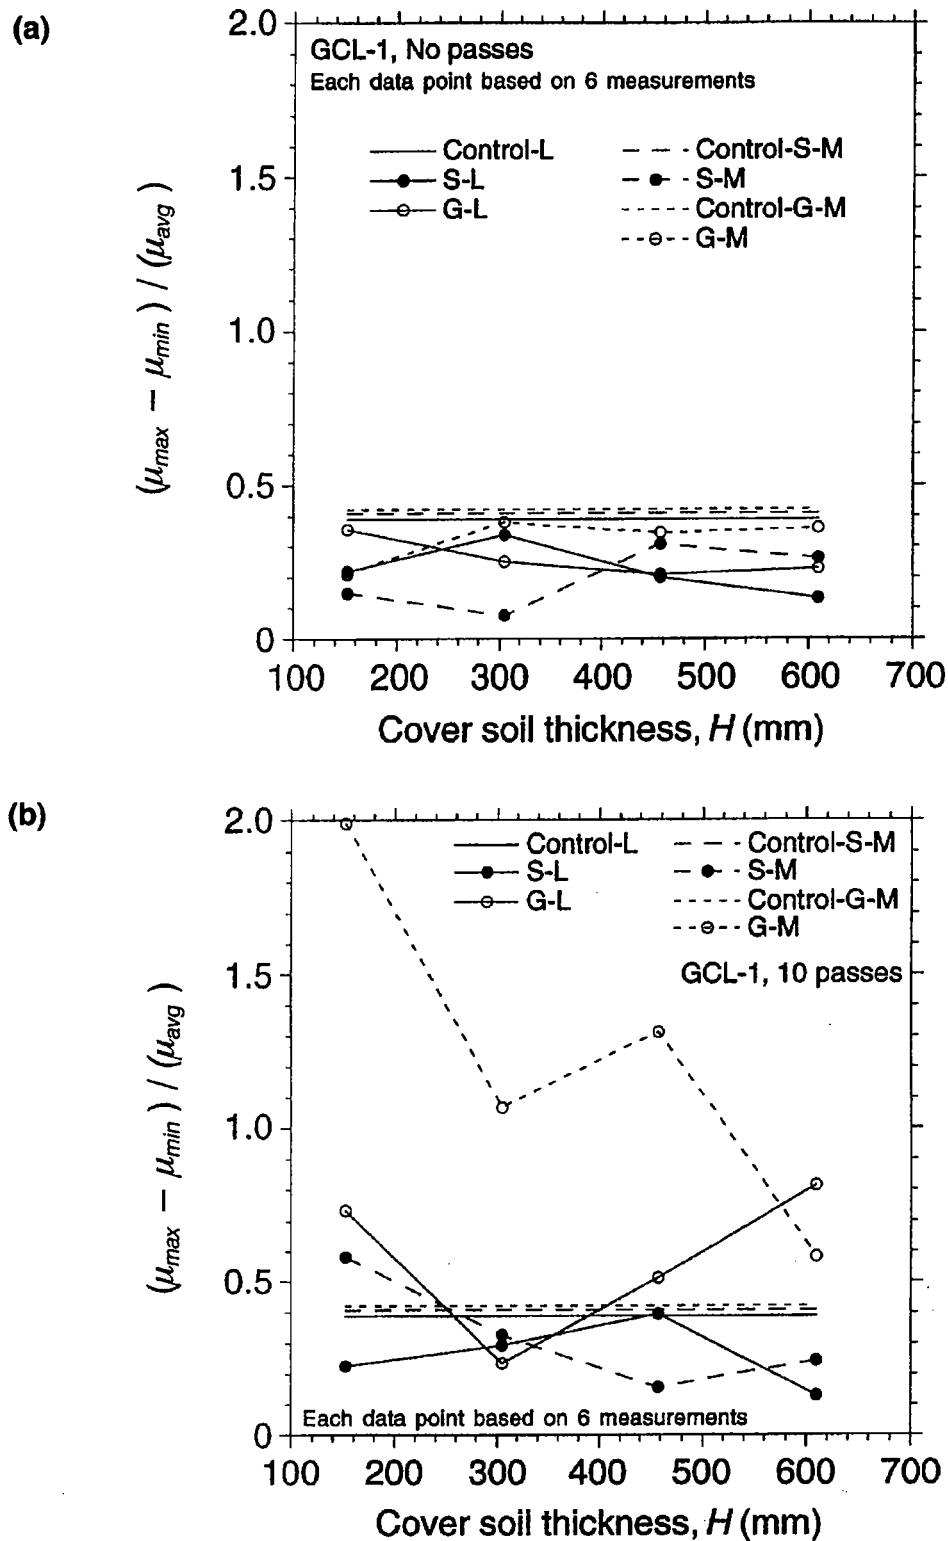
Figure 14. Bentonite $(\mu_{max} - \mu_{min}) / (\mu_{avg})$ values of GCL-1 for: (a) no passes; (b) 10 passes after hydration.

Values of $(\mu_{max} - \mu_{min}) / (\mu_{avg})$ for GCL-1 specimens are presented in Figure 14, where μ_{max} , μ_{min} , and μ_{avg} are the maximum, minimum, and average values of six measurements of local mass per unit area for each specimen. The values give an indication of the relative variability of GCL mass per unit area. Interestingly, GCL-1 field specimens, which received no passes after hydration, show lower variability of local mass per unit area values than the corresponding control specimens. For 10 passes, local mass per unit area variability for the G-M specimens increases significantly with decreasing H . Values of $(\mu_{max} - \mu_{min}) / (\mu_{avg})$ approach 2.0 for $H = 152$ mm, suggesting that bentonite was nearly absent from the thinnest locations of these specimens. This is consistent with field observations. Corresponding plots of $(\mu_{max} - \mu_{min}) / (\mu_{avg})$ for GCL-2 (Figure 15) indicate that bentonite migration was insignificant for each field installation condition, which is also consistent with field observations.

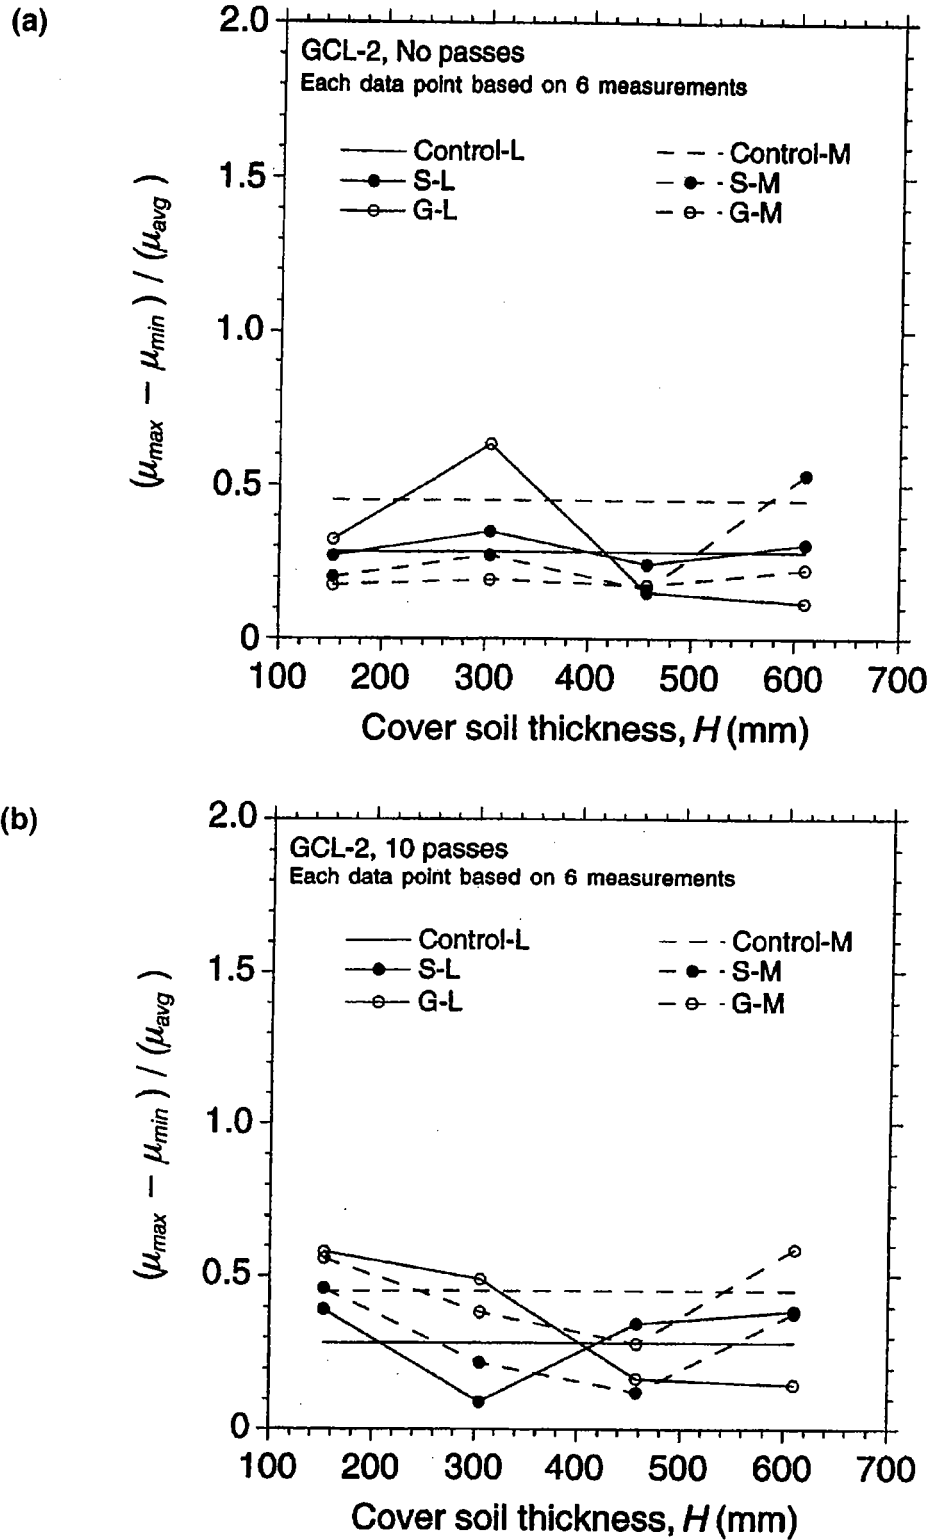
Figure 15. Bentonite $(\mu_{max} - \mu_{min}) / (\mu_{avg})$ values of GCL-2 for: (a) no passes; (b) 10 passes after hydration.

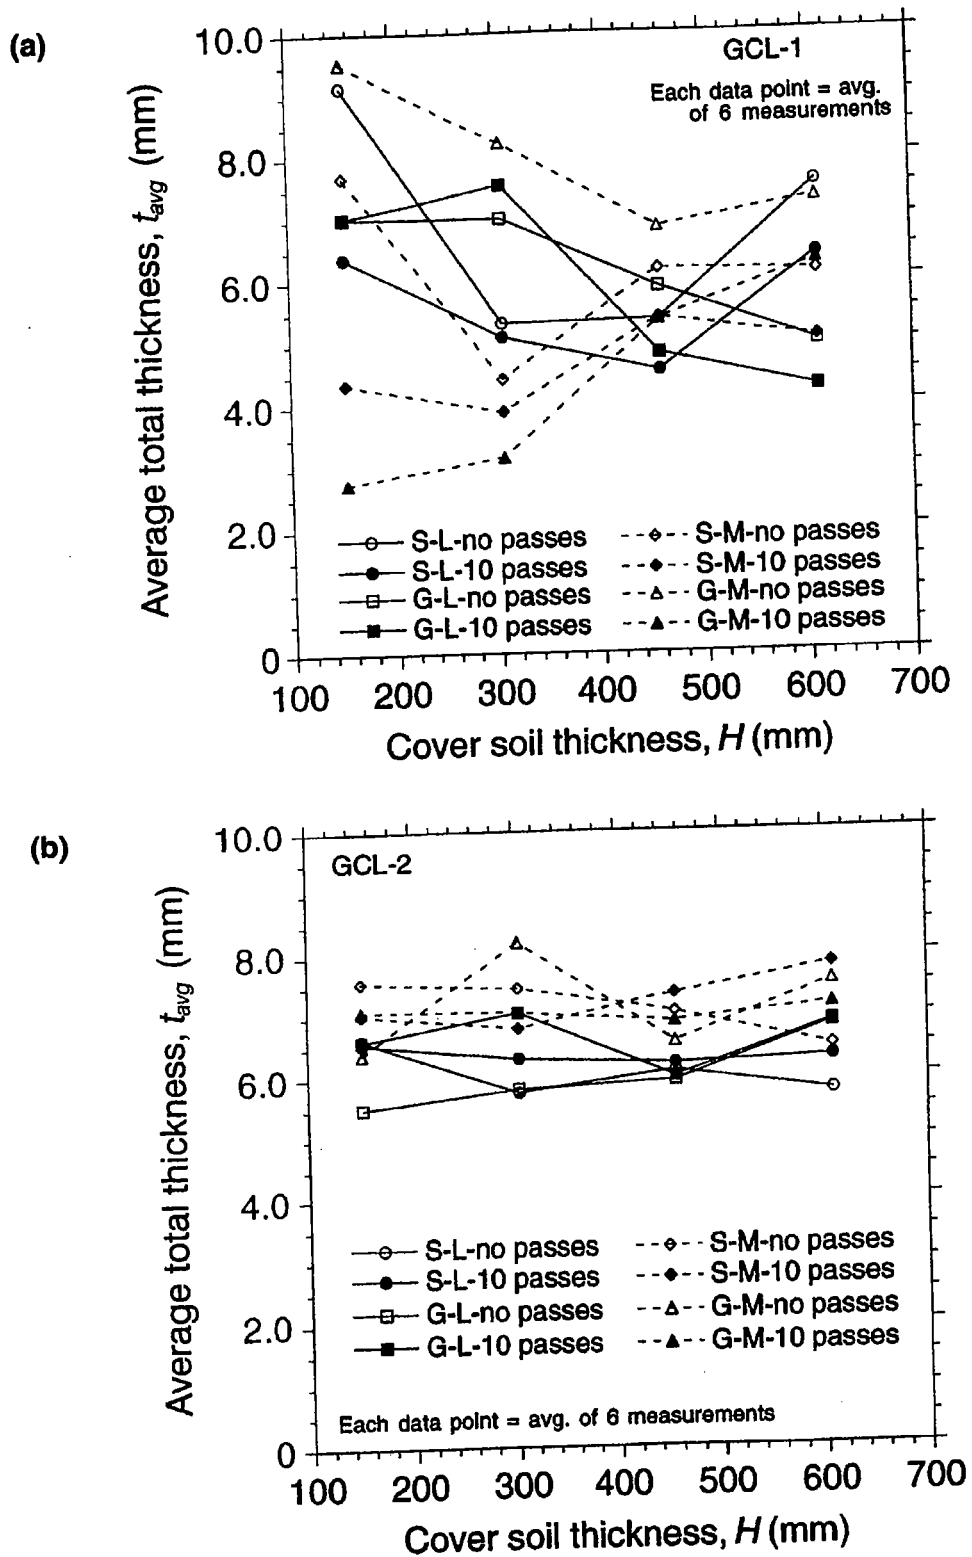
Figure 16. Average total thickness values for: (a) GCL-1; (b) GCL-2.

The average of six thickness measurements, t_{avg} , for each GCL-1 field specimen is shown in Figure 16a. Values of t_{avg} for no passes after hydration range from 4.4 to 9.5 mm and, similar to the trend of w in Figure 11a, generally increase with decreasing H . Values of t_{avg} for 10 passes after hydration are typically smaller, ranging from 2.6 to 8.5 mm. Consistent with the reduction of μ shown in Figure 12b, t_{avg} for the G-M specimens decreases significantly with decreasing H , reaching a value of 2.6 mm at $H = 152$ mm. Values of t_{avg} for GCL-2 (Figure 16b) are more consistent than those for GCL-1, ranging from 5.5 to 8.2 mm. In addition, t_{avg} is essentially independent of H and the number of passes after hydration. Values of t_{avg} for S-M and G-M are generally higher due to the higher water contents of these specimens (Figure 11b).

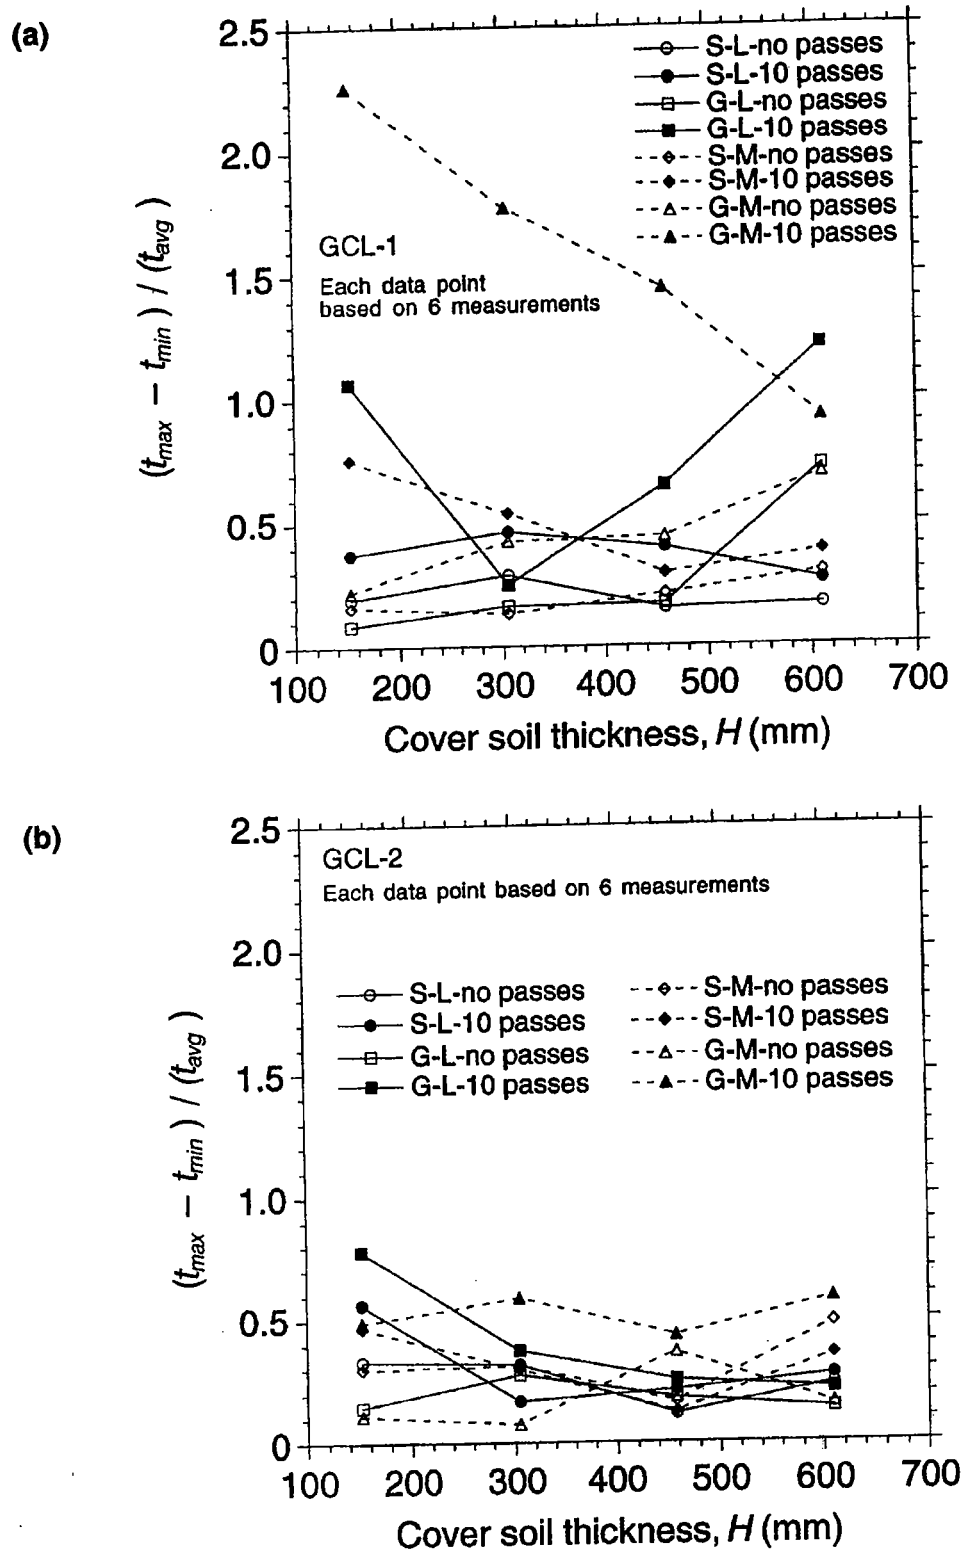
Figure 17. $(t_{max} - t_{min}) / t_{avg}$ values for: (a) GCL-1; (b) GCL-2.

Figure 17 presents $(t_{max} - t_{min}) / t_{avg}$ for GCL-1 and GCL-2, where t_{max} and t_{min} are the maximum and minimum values of six thickness measurements for each field specimen. The GCL-1 thickness shows more variability for 10 passes after hydration, especially for the gravel-covered specimens. Values of $(t_{max} - t_{min}) / t_{avg}$ for the G-M specimen increase sharply with decreasing H , reaching nearly 2.3 for $H = 152$ mm. This suggests that, for $H = 152$ mm, the G-M specimen was locally very thin, which is consistent with field observations. Variability of individual thickness measurements is less for GCL-2. Values of $(t_{max} - t_{min}) / t_{avg}$ for 10 passes after hydration are generally larger, with a maximum of 0.8 for G-M at $H = 152$ mm.
