## Technical developments related to the problem of GCL panel shrinkage when placed below an exposed geomembrane

R. Thiel. Thiel Engineering, Oregon House, CA, USA. [richard@rthiel.com](mailto:richard@rthiel.com)

R.K. Rowe. GeoEngineering Research Centre at Queen's-RMC, Queen's University, Kingston, ON, Canada. [kerry@civil.queensu.ca](mailto:kerry@civil.queensu.ca)

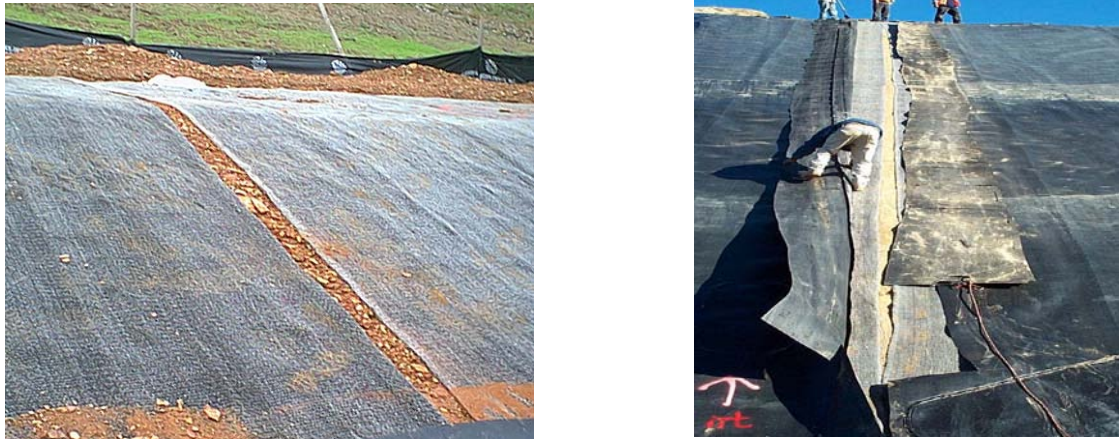
Figure 1. Photographs of actual GCL panel separation problems at two different projects in the USA.

The shrinkage of fabric-supported reinforced GCL panels in the field has been known and managed since the early 1990s. This problem was not widely discussed, however, and, until 2005, the potential for this to occur with reinforced products was virtually unmentioned. Thiel and Richardson (2005) first publicly documented the potential problem of shrinkage of reinforced GCLs covered by a geomembrane (GM) and left exposed (i.e. with no overlying cover soil) in 2005. Thiel et al. (2006) summarized six cases (Table 1) in which GCL panels that reportedly had originally been overlapped by 0.15 m had separated at their overlaps, leaving a gap between panels of between 0.20 and 1.20 m after periods of exposure of between 2 and 36 months. Koerner and Koerner (2005a, 2005b) noted two other examples in which GCL panels had either lost a portion of their original overlap or had completely separated. Examples from two projects are shown in Figure 1.

The factor common to all the field cases in which shrinkage was observed is that the GCLs had been overlain by a geomembrane that was left uncovered (i.e. continuously exposed to meteoric conditions) for periods ranging from two months to five years. A likely reason that relatively few cases of this problem have been documented is that it is quite uncommon to cut open a geomembrane that has been installed and fully certified by a CQA program. In fact, in the primary author's 20 years of field experience with CQA, he has never once been called upon to perform this task, except for the edge tie-ins required for cell expansion. In all the case histories in which GCL panel separation was observed, there was some unique, non-typical cause that required the underlying GCL to be uncovered from the previously-installed geomembrane.

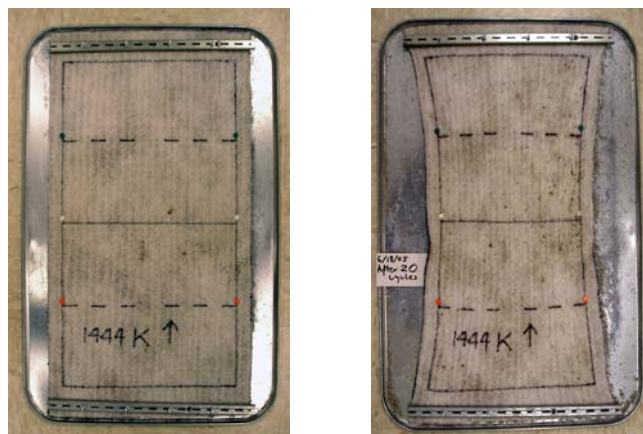
Figure 2. GCL sample (left) before testing and (right) after 20 wetting-drying test cycles.

Several initial laboratory studies (Thiel et al. 2006; Bostwick et al. 2007, 2008, 2010) have been able to replicate the magnitude of the GCL shrinkage phenomenon. These studies were accomplished by placing GCL samples that were cut to approximate dimensions of 0.35 m by 0.60 m on aluminum pans with their as-received water content. The two small ends of the samples were clamped using a continuous bar-clamp screwed to the pans. The samples were then subjected to cycles of wetting and drying (generally at 60°C). The results indicated that shrinkage of up to approximately 25% could be induced in the laboratory by the application of cyclic wetting and drying, and that some products were more susceptible to shrinkage than others. Figure 2 shows a typical laboratory test sample. Figure 3(a) shows the cyclic progression of shrinkage and expansion through 20 cycles of wetting and drying, with a net unrecoverable shrinkage. Figure 3(b) shows a comparison of the results from several different GCL products after the 40th drying cycle.

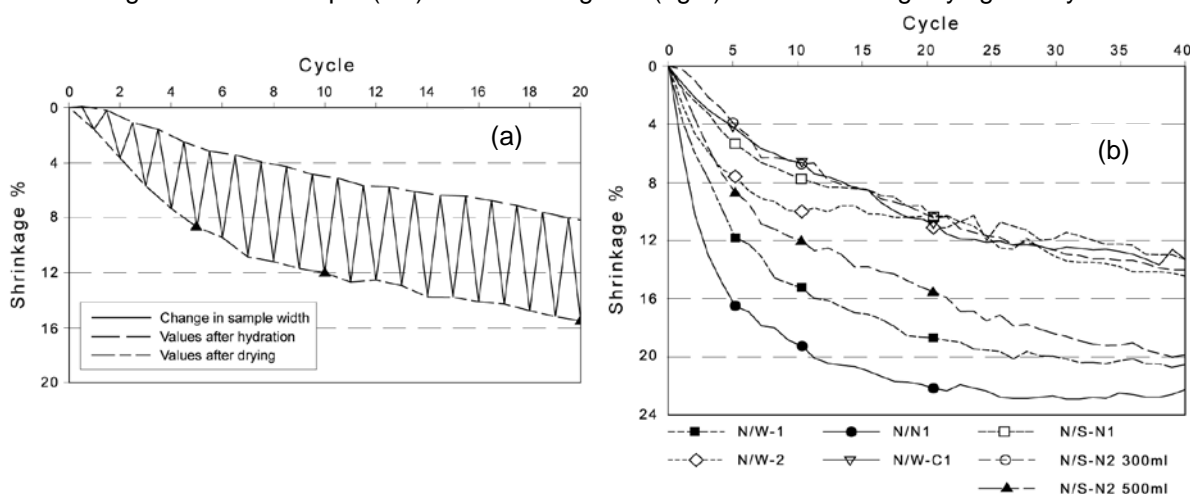
Figure 3. (a) Example of laboratory pan test results for change in sample width (expressed as percent of shrinkage) vs. cycle number. (b) Shrinkage vs. cycle number for different types of geotextile-encased GCL samples tested (values after drying). (from Thiel et al. 2006)

Some of the conclusions drawn from the testing performed by Thiel et al. (2006) were: (1) needlepunched GCLs that have only nonwoven geotextiles exhibit the highest propensity for shrinkage, while those that contain a woven or scrim geotextile exhibit a lower shrinkage potential; (2) a greater intensity of needlepunching appears to result in a lower tendency toward shrinkage; and (3) less water supply in each wet/dry cycle reduces the amount of shrinkage that occurs in that cycle.

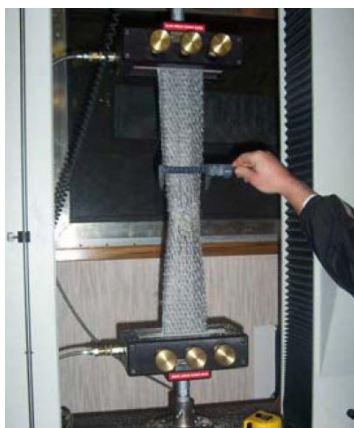
Figure 4. Example of laboratory tension-necking test. (courtesy of Koerner and Koerner 2005a)

possibilities they believed that mechanism 2 (slope tensioning) is the major factor that contributes to the problem in the field. By performing laboratory tension tests, they demonstrated tension-necking due to a sort of "Poisson's effect" linked to tension in the longitudinal direction. An example of their testing-in-progress is presented in Figure 4. Inspection of Table 1, however, indicates that significant shrinkage and loss of overlap occurred in 2 months at locations where the slope was only 4°. Furthermore, unpublished research from a field test site in Godfrey, Ontario (Brachman et al. 2007) suggests that shrinkage on the base (3° slope) is not necessarily less than that on an 18° slope under nominally similar conditions. Thus, while tensioning on a slope may contribute to panel separation, the authors do not consider it to be the primary mechanism that causes shrinkage and loss of overlap.

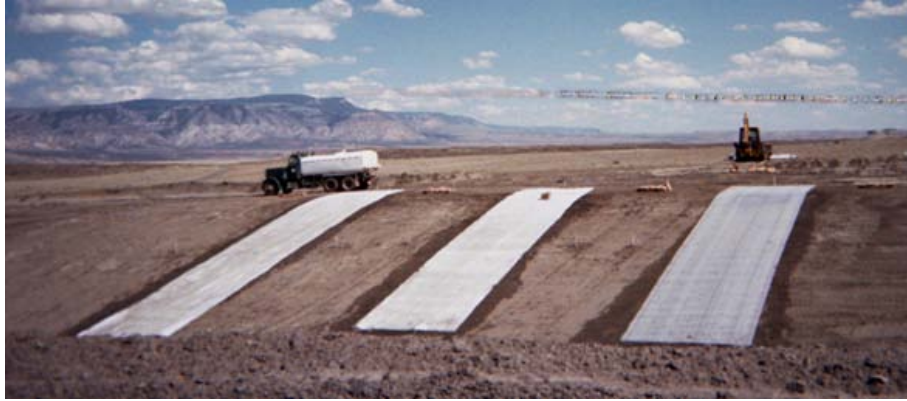
Figure 5. CETCO field study. (courtesy of CETCO 2006)

CETCO (2006) constructed test plots in Wyoming in July 2004. Full-width GCL panels were laid on 3H:1V slopes, and moisture sensors and movement telltales were installed in the GCL. The soil subgrade was a silty clay with a little fine sand and had a natural moisture content of approximately 5%. The GCL was then sprayed with water to increase its moisture content (Figure 5) and covered with a smooth geomembrane. Monitoring equipment was attached to stations. Measurements of the geomembrane surface temperature in the summer indicated temperatures that reached over 60°C. The

field instrumentation indicated that over the test period of 10 months, the GCL only went through a half cycle of moisture variation (from a high of over 40% to a low of 11%) and experienced a shrinkage of only 0.025 – 0.037 m (0.6-0.9% strain), which is significantly less than the shrinkage observed in some of the case histories.

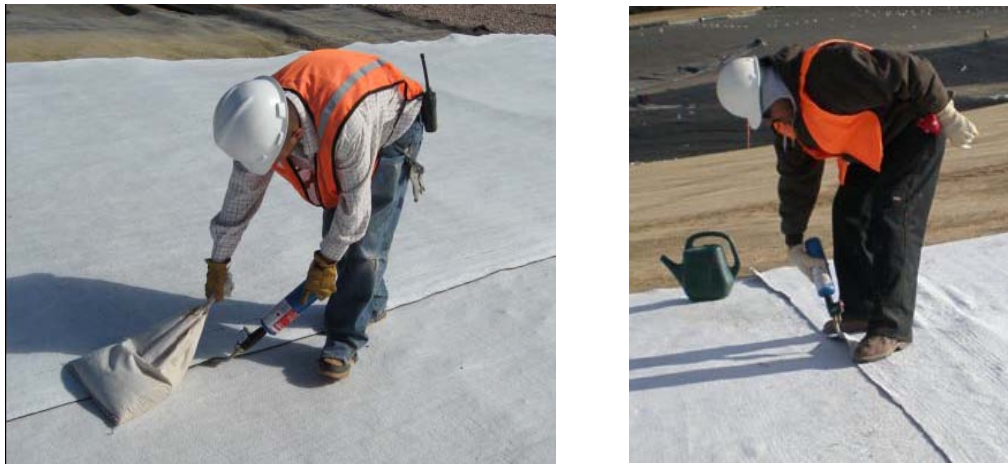
Figure 6. Installer heat-tacking GCL edge seam with a 0.15 m overlap.

Thiel and Thiel (2009) reported a case history in which two types of reinforced GCL products (N/N and W/N) were installed with 0.15 m seam overlaps and covered with a black textured geomembrane. The installer heat-tacked every GCL seam with the quick application of a flame torch that was immediately followed by the application of light but firm pressure. The heat tacking was continuous along all overlaps. Figure 6 shows the technician heat-tacking the seam with a torch, followed by the application of light pressure either in the form of a sand bag dragged along the seam, or the steady, intentional use of foot pressure. The technician could thus effectively seal the seam in a manner that added negligible material and labor cost. GCL seam exhumations were performed at mid-slope in six separate areas of the project between the months of February and June after 60 to 90 days of exposure. The air temperature during this period fluctuated from below 0°C to above 32°C. In every instance there was no evidence of any GCL shrinkage and the heat-tacked GCL seam remained intact. Samples of the heat-tacked seams were sent to Queen's University in Canada for laboratory testing, as described by Rowe et al. (2009, 2010), which confirmed the integrity of the heat-tacked seams.
